ARKANSAS DEPARTMENT OF TRANSPORTATION

SUBSURFACE INVESTIGATION

STATE JOB NO. 020791

HWYS. 82, 270 & 278 SLIDE REPAIRS (S)

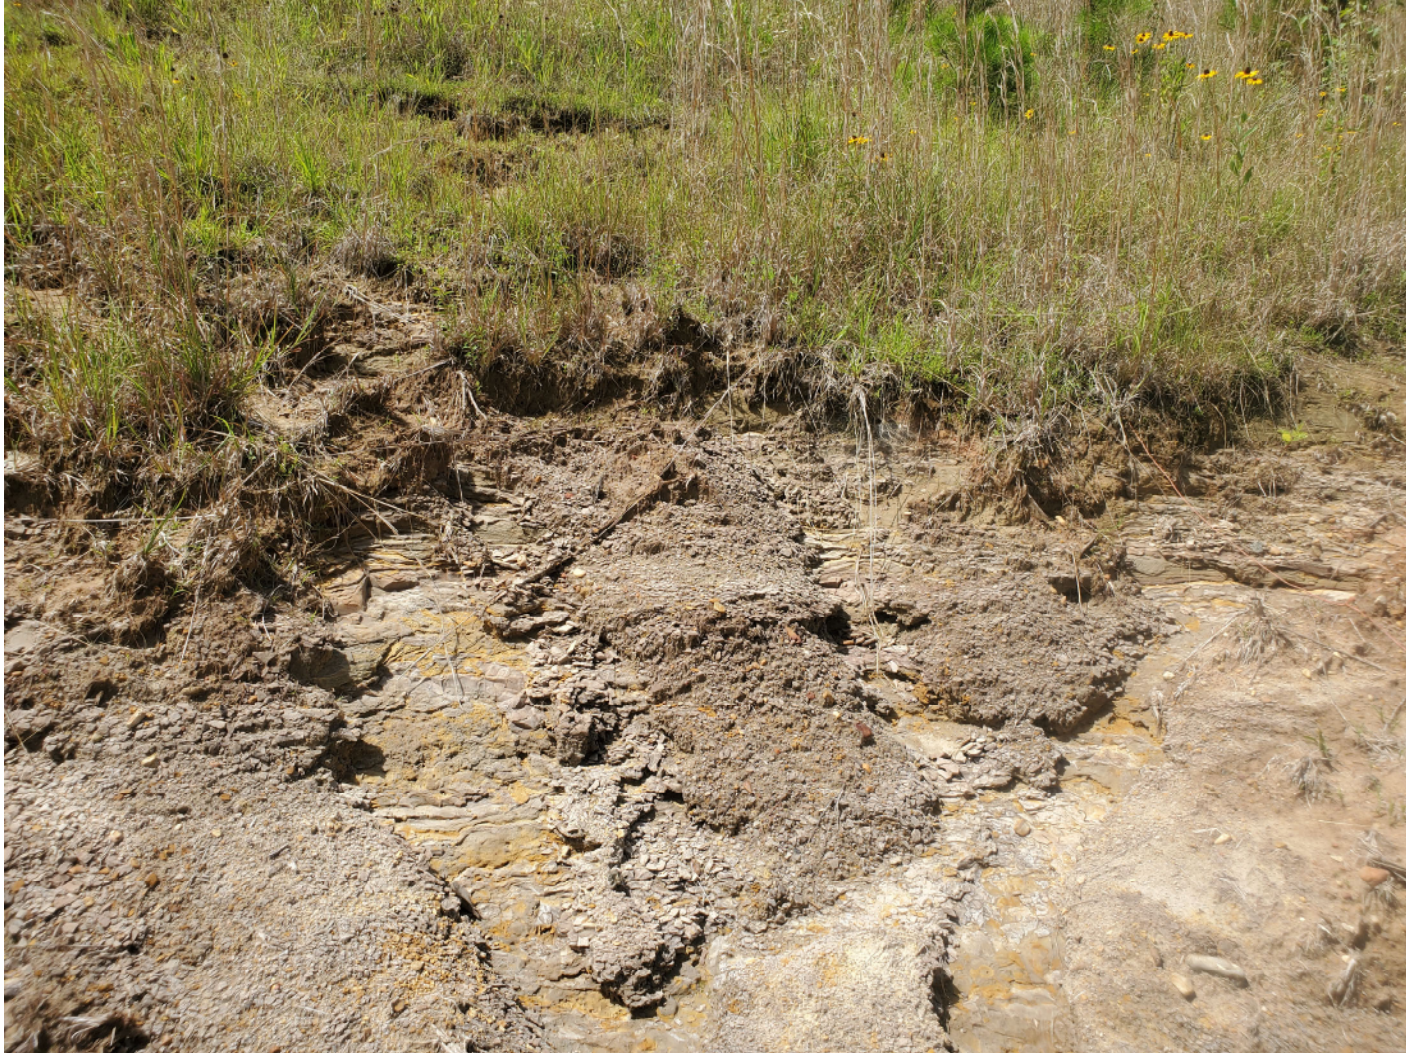
## SITE PICTURES

Monticello Multiple  
Locations of Slides

District 2 recommends reshaping these areas of the slopes and added topsoil and seeding in order to correct these spots.
