Bridge #03021(Routine)

SH 35 Log 4.92 over HOLLY CREEK

Location: 2.0 MI S OF BENTON

Team Lead: Chris Doggett Inspection Date: March 03, 2022

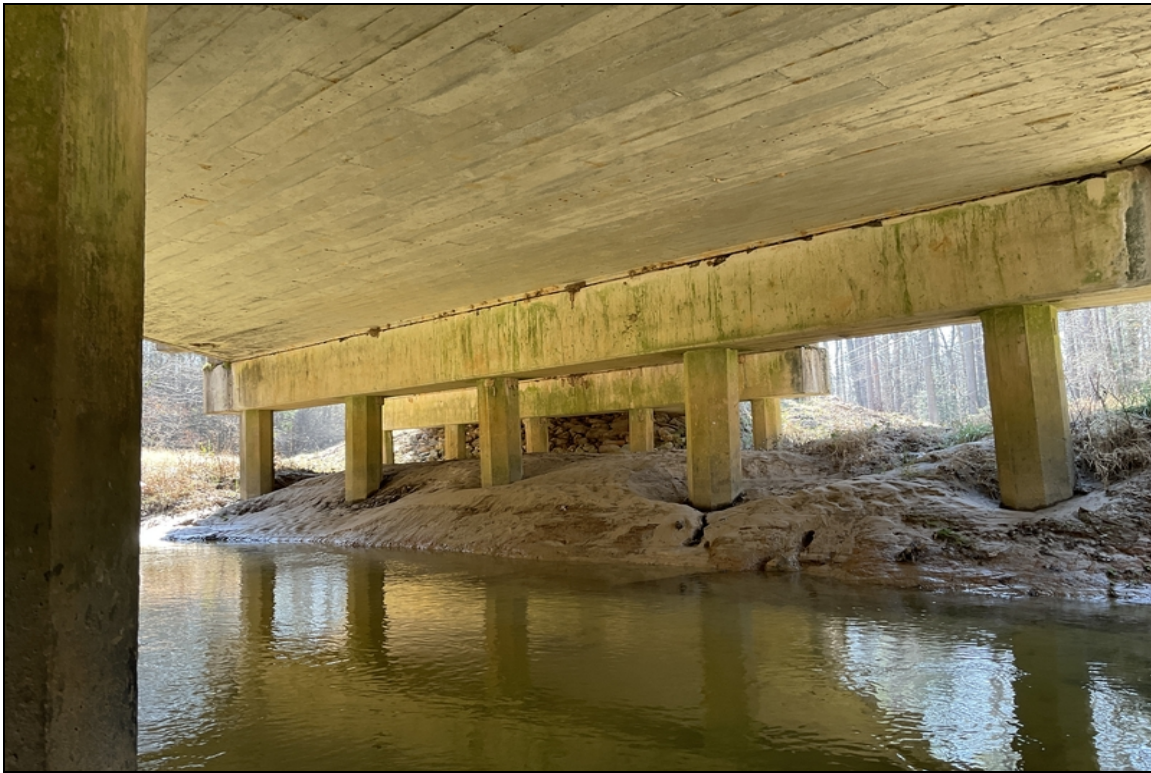
Soffit view

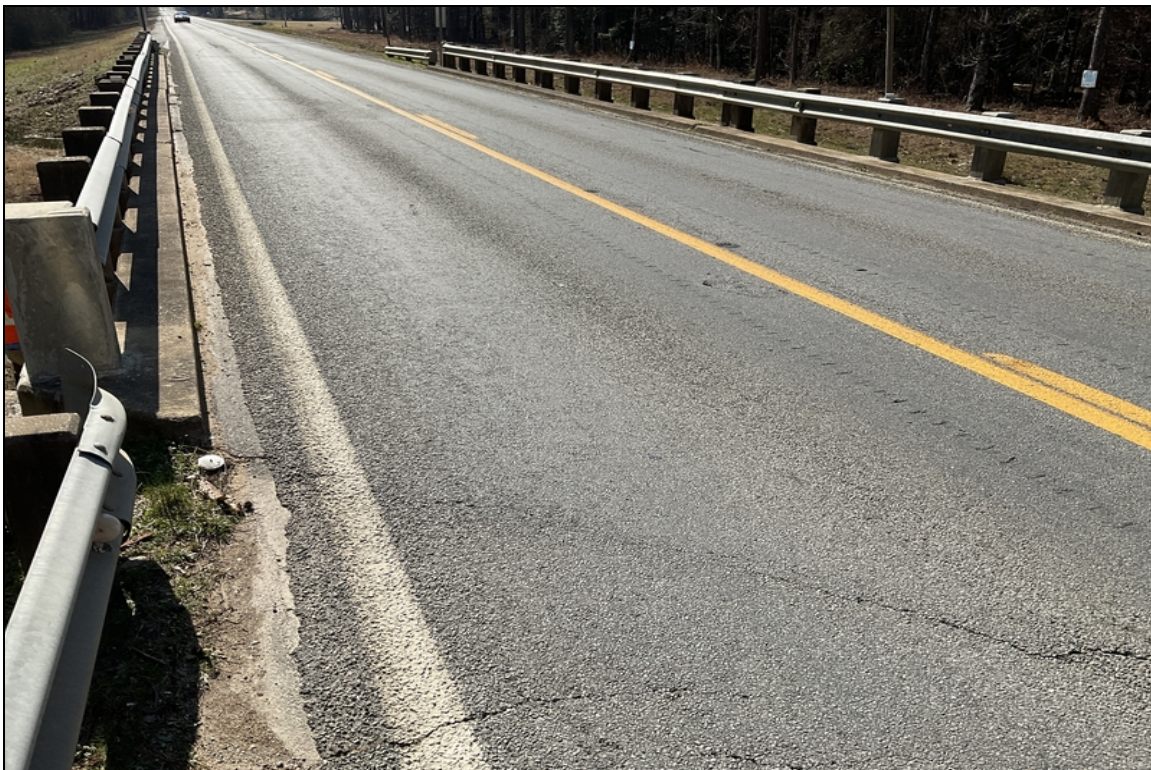
Deck view

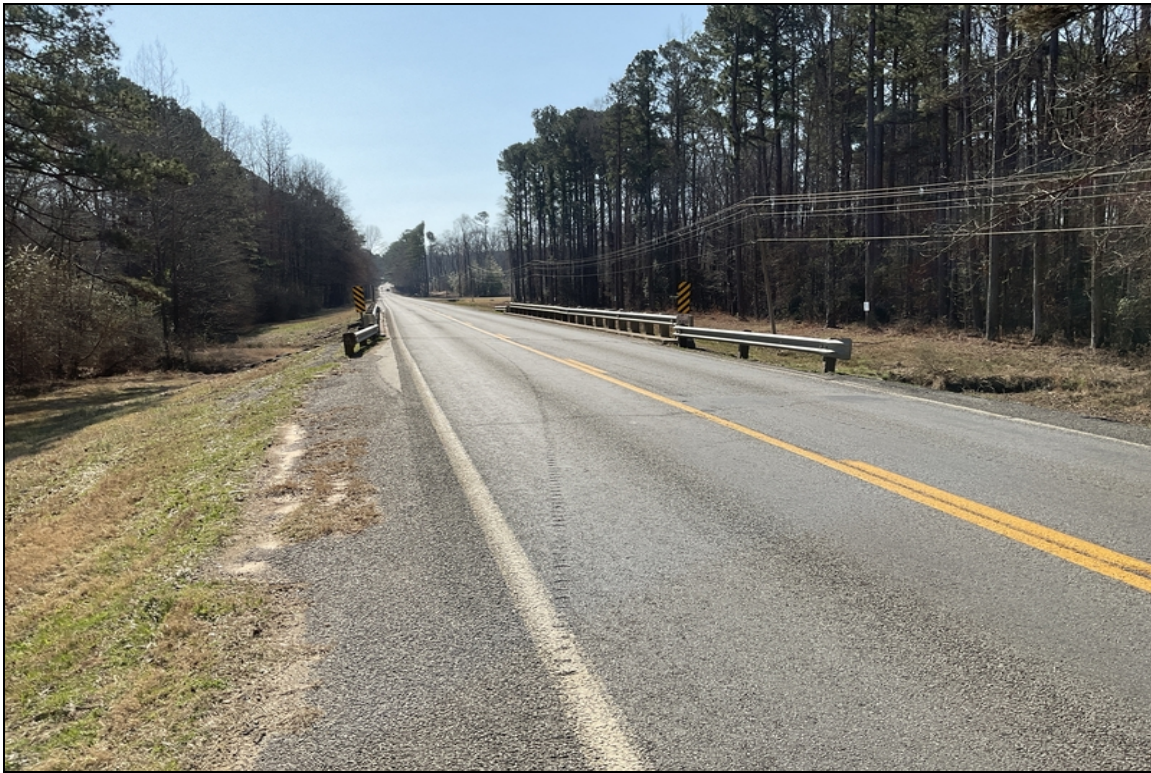
Inventory looking south
