WRONG-WAY CRASH STUDY

INTERSTATES AND FREEWAYS | CALENDAR YEAR 2020

Published March 2023

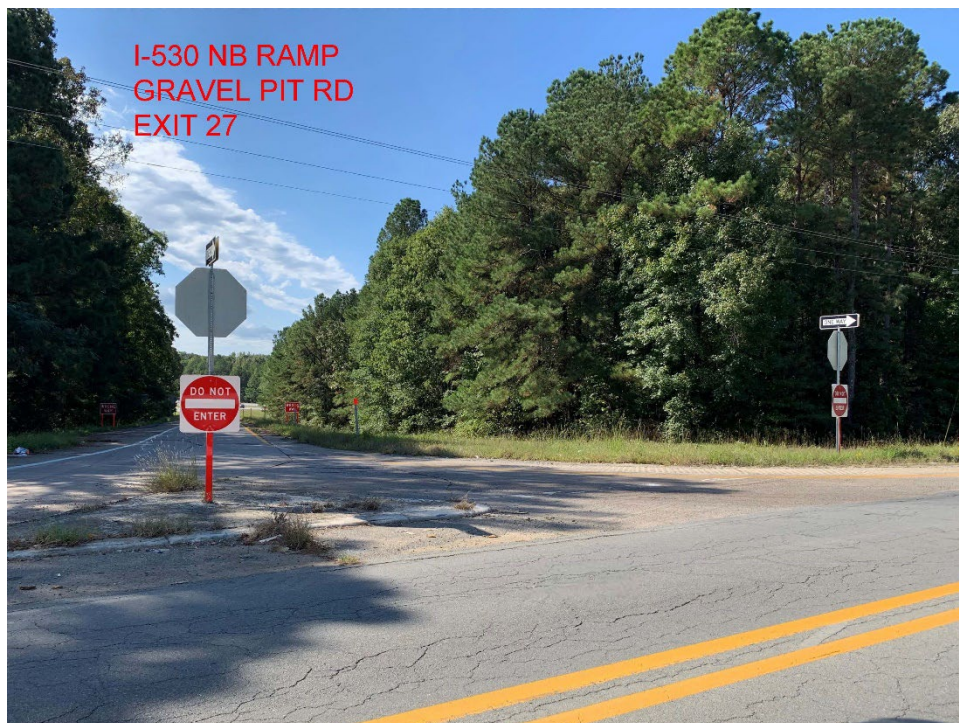
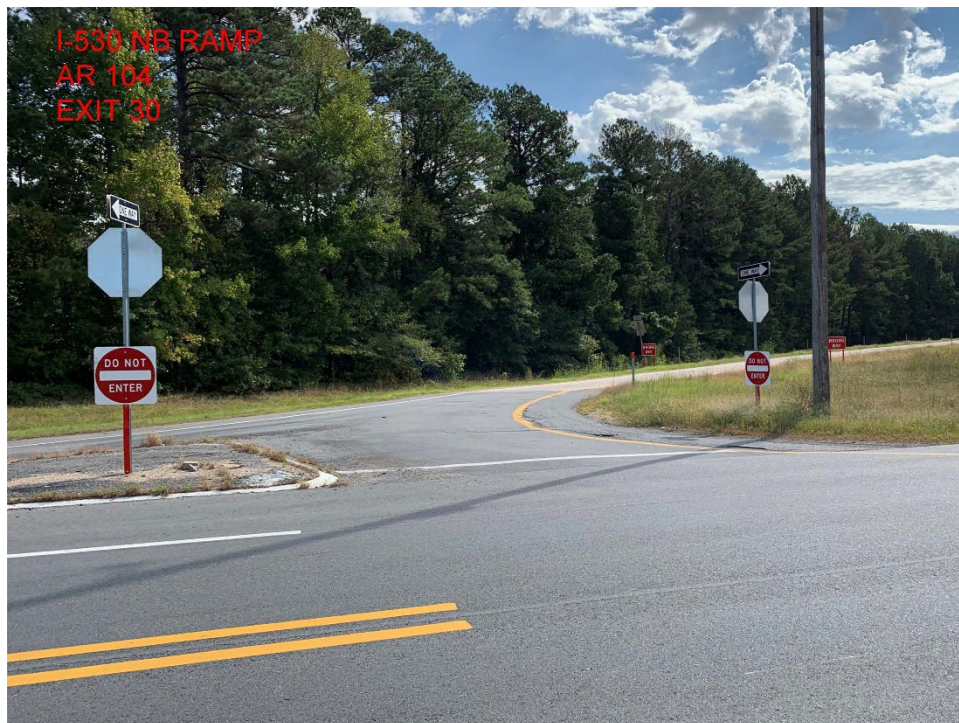
Crash # 2020505271 I-530, Section 5, Direction B, Log Mile 12.495

The interchange at Exit 27 was reviewed. Signs were in place and in conformance with MUTCD and ARDOT requirements. However, all pavement markings (stop bar, yield bar, and arrow) had faded and were replaced to be consistent with current ARDOT requirements on March 23, 2022.

The interchange at Exit 32 was reviewed. Signs were in place and in conformance with MUTCD and ARDOT requirement. However, the arrow pavement marking was installed to be consistent with current ARDOT requirements on March 23, 2022.

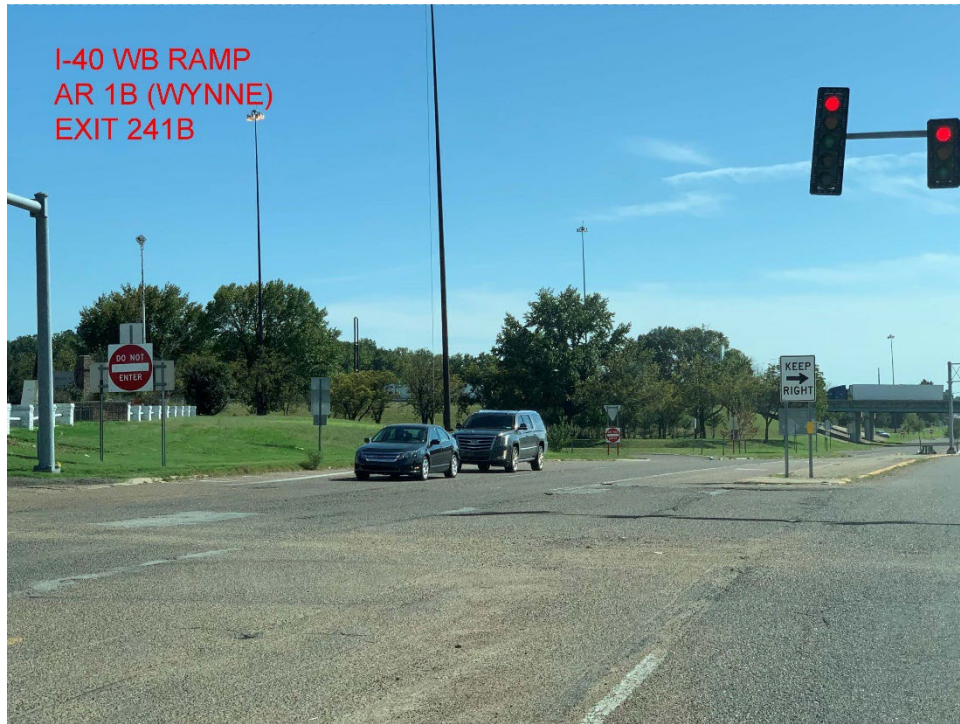
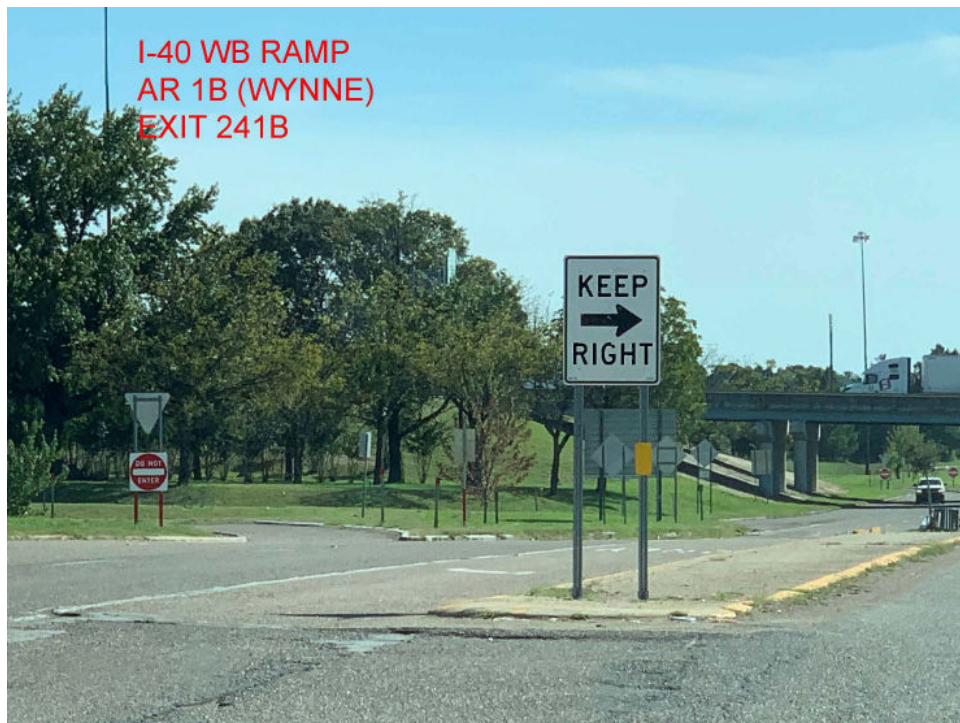
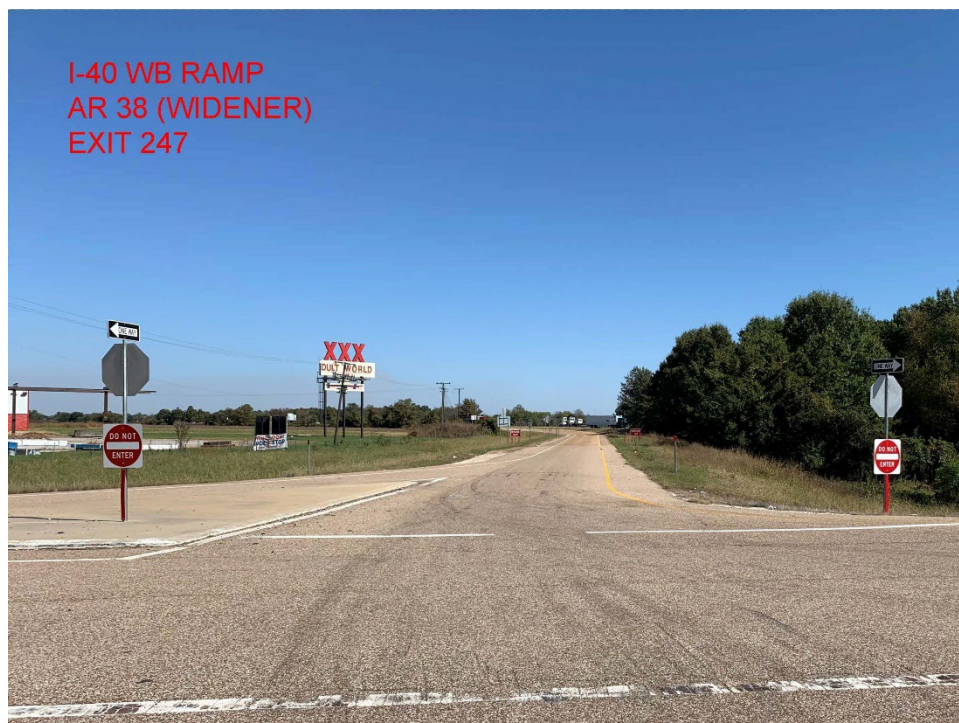
Crash # 2020522977 I-40, Section 51, Direction B, Log Mile 28.203

The interchange at Exit 241B was reviewed. Pavement markings and signs were in place and in conformance with MUTCD. However, the 36"x36" Do Not Enter sign was missing but was installed to be consistent with current ARDOT requirements on February 14, 2022.

The interchange at Exit 242 was reviewed. Signs were in place and in conformance with MUTCD and ARDOT requirements. However, the pavement markings (stop bar) had faded and needed to be replaced and the pavement marking arrow needed to be moved up 275 ft. to be consistent with current ARDOT requirements. These modifications were implemented on February 14, 2022.

The interchange at Exit 247 was reviewed. Signs were in place and in conformance with MUTCD and ARDOT requirements. However, the pavement marking arrow needed to be moved up 256 ft. to be consistent with current ARDOT requirements. These modifications were implemented on February 14, 2022.

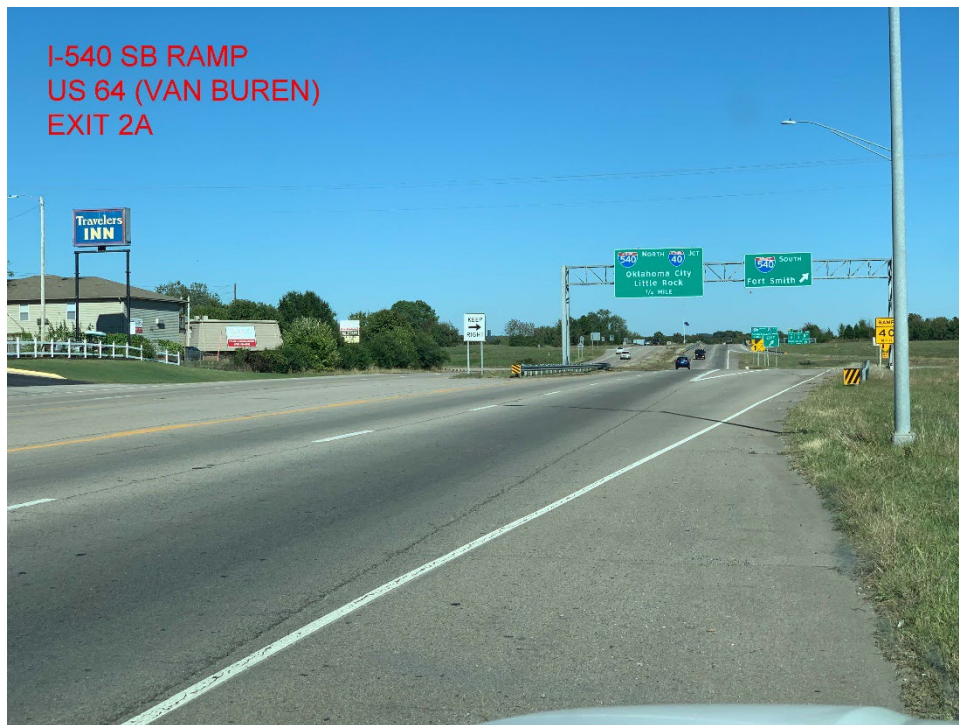
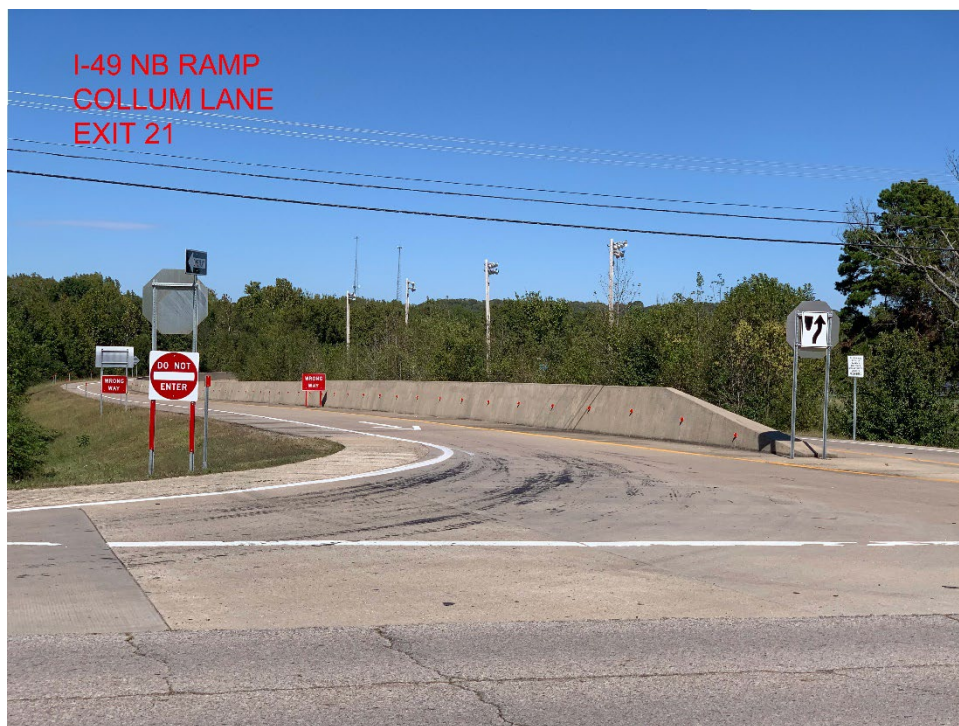
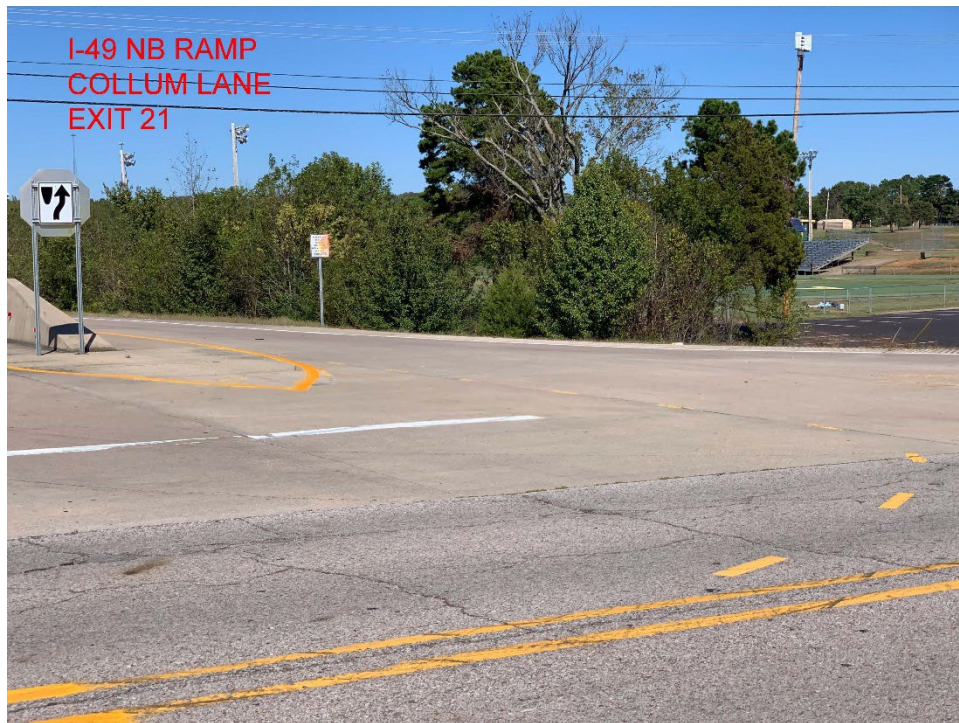
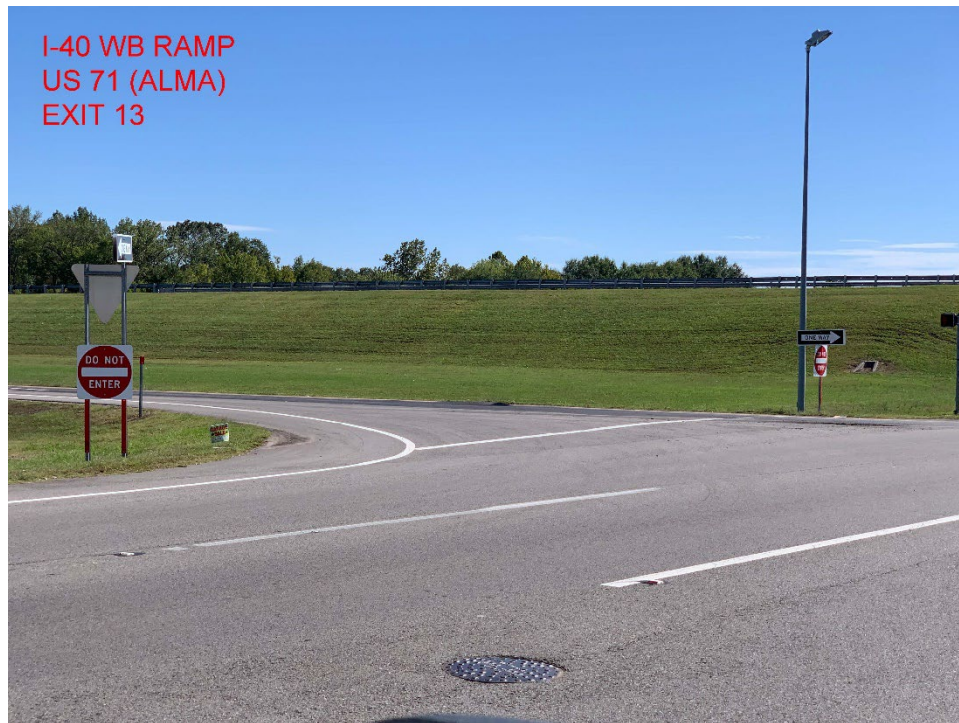
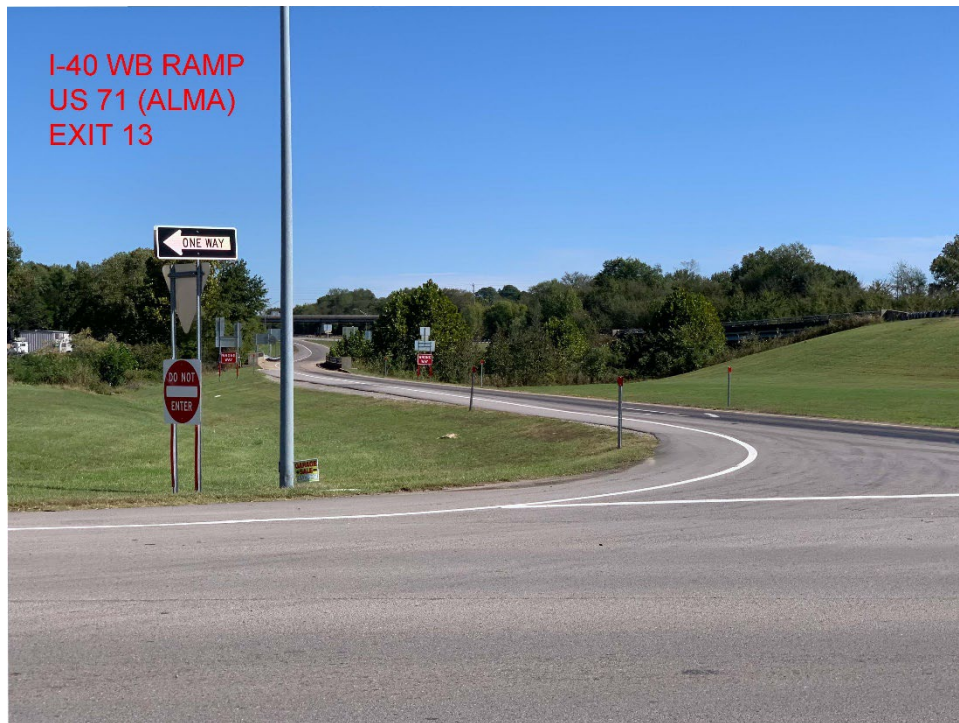
Crash # 2020525972 I-40, Section 11, Direction B, Log Mile 265.145

The interchange at Exit 7 and Exit 2A was reviewed. Pavement markings and signs were in place and in conformance with MUTCD. However, the 48"x48" Do Not Enter sign was missing. It was installed to be consistent with current ARDOT requirements on February 8, 2022.

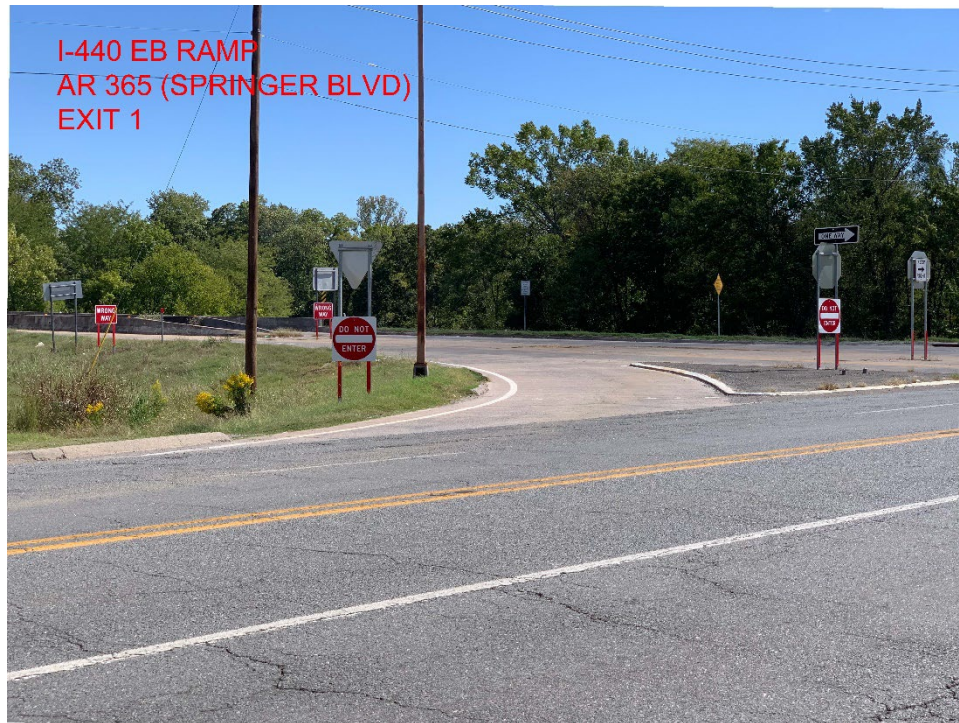
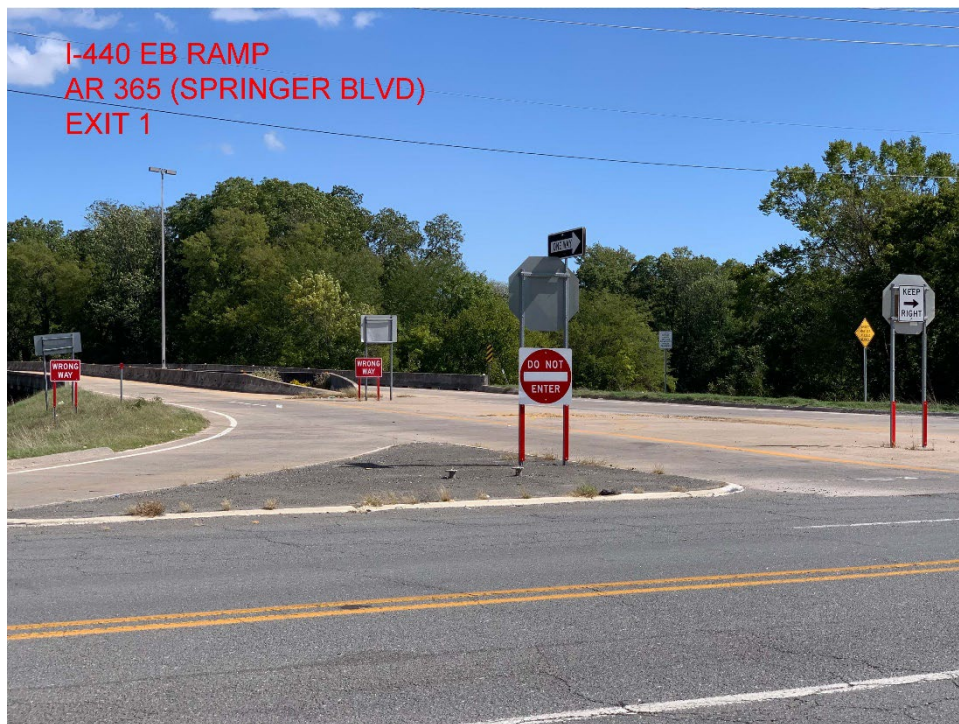
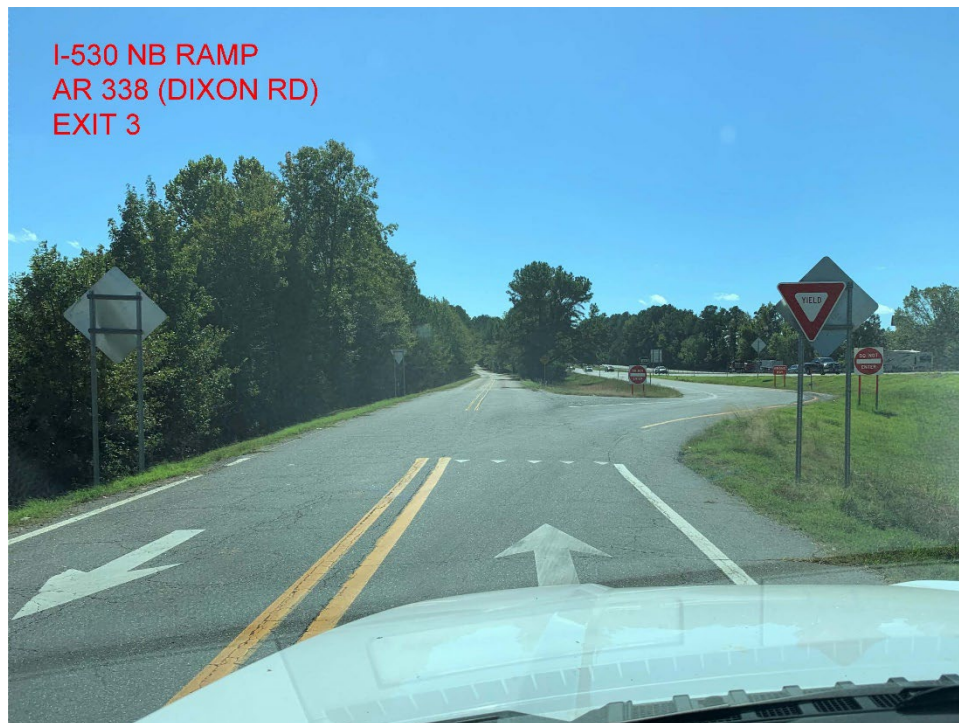
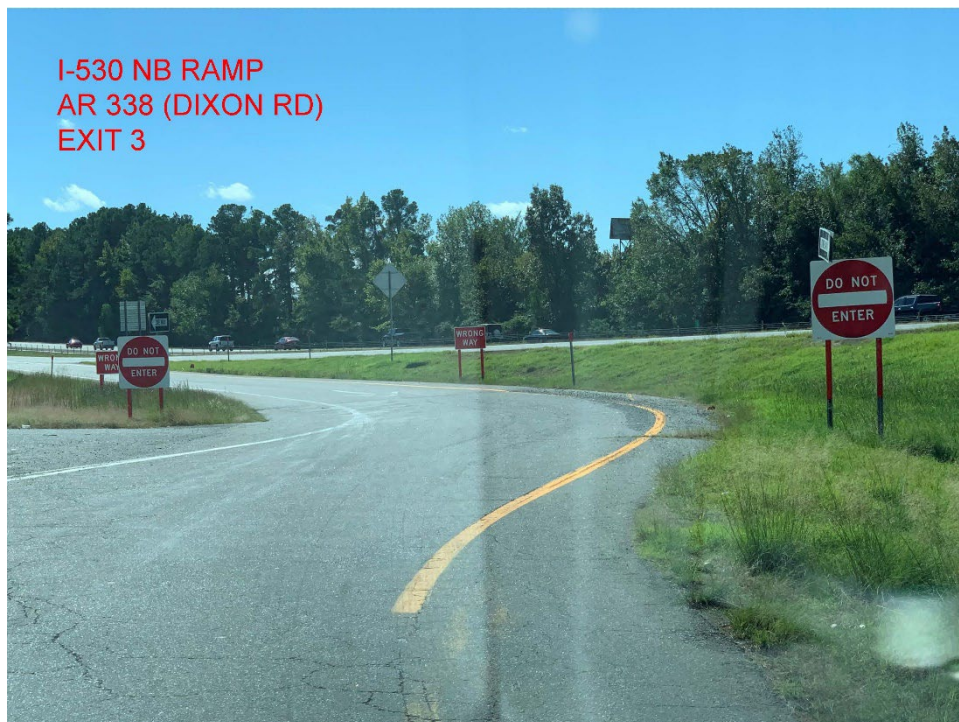
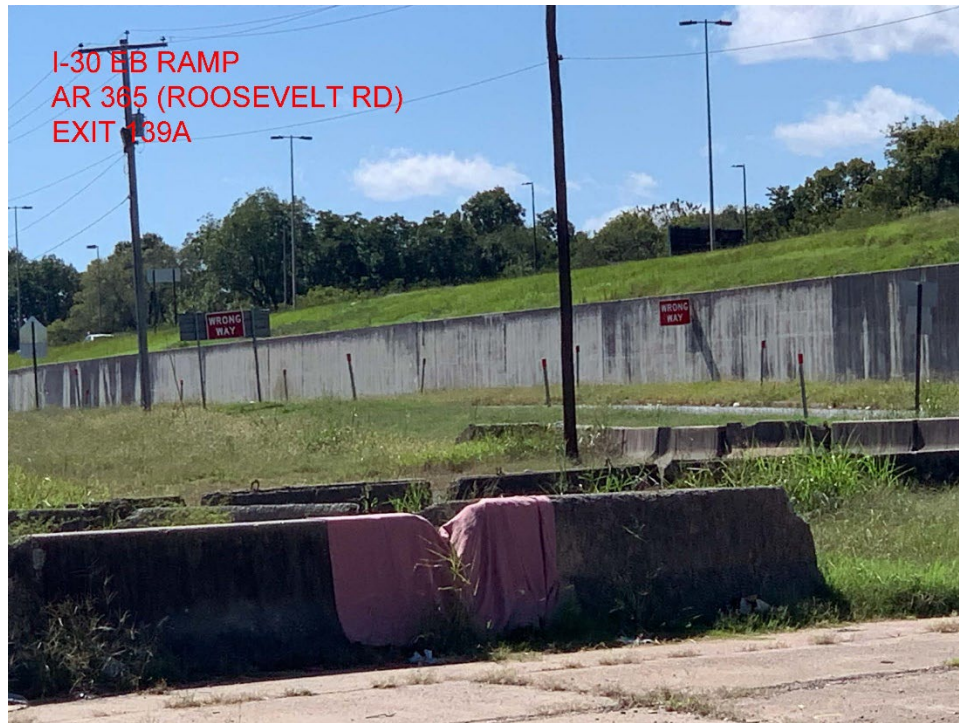
Crash # 2020529929 I-530, Section 1, Direction B, Log Mile 41.819

The interchange at Exit 1 on I-440 was reviewed. Signs were in place and in conformance with MUTCD and ARDOT requirements. However, all Pavement markings (stop bar, yield bar and arrow) had faded but were replaced to be consistent with current ARDOT requirements on December 15, 2021.

The interchange at Exit 139A on I-30 was reviewed. Signs were in place and in conformance with MUTCD. However, the 42"x30" Wrong Way sign was missing and needed to be replaced. It was installed to be consistent with current ARDOT requirements on December 15, 2021.

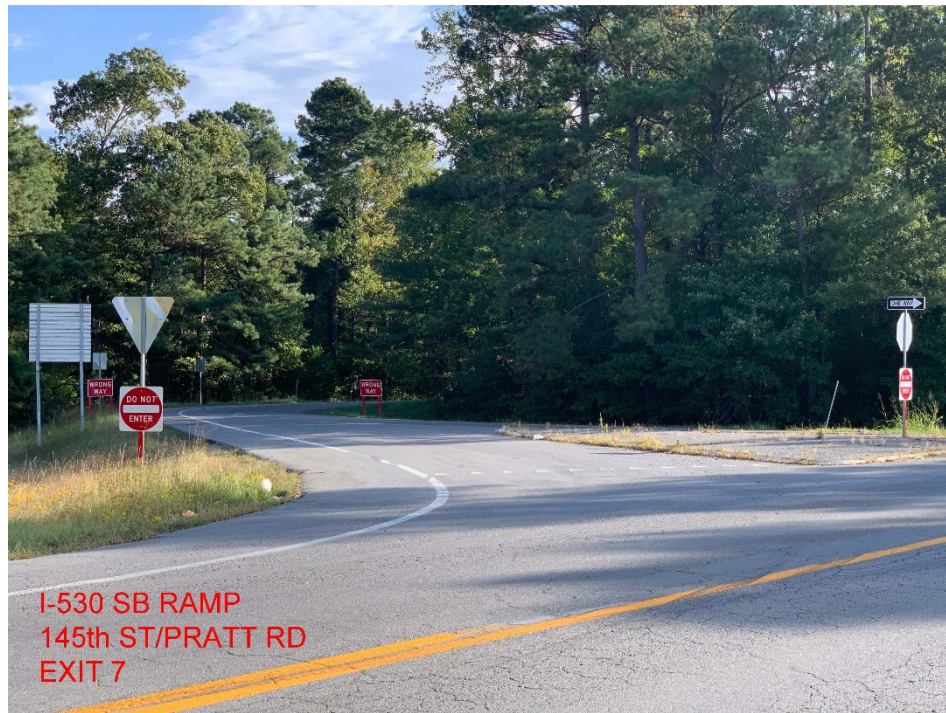
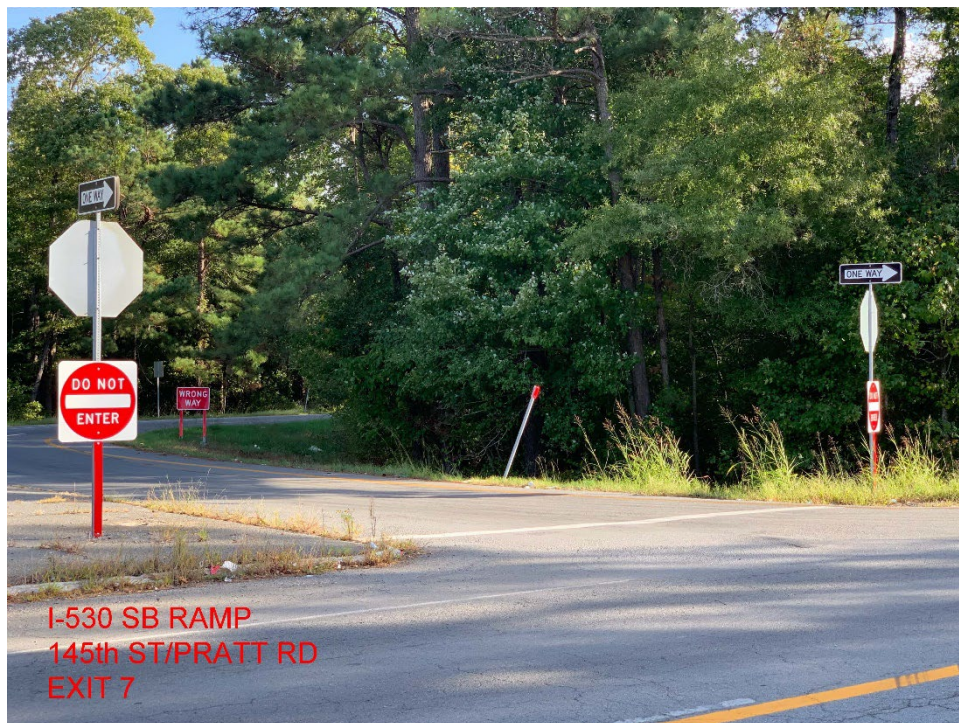
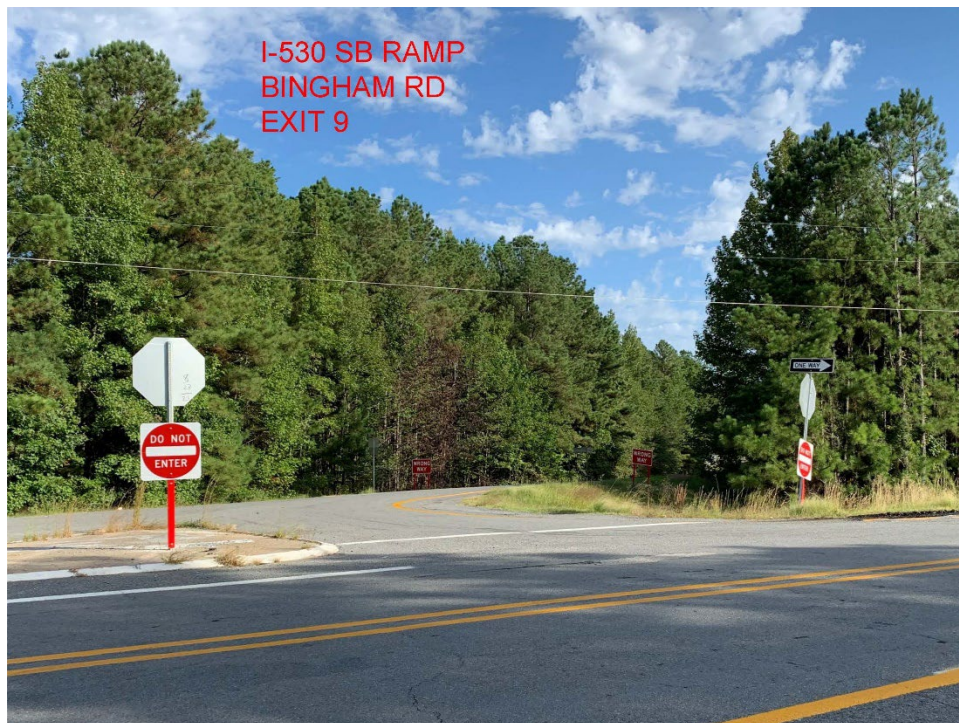
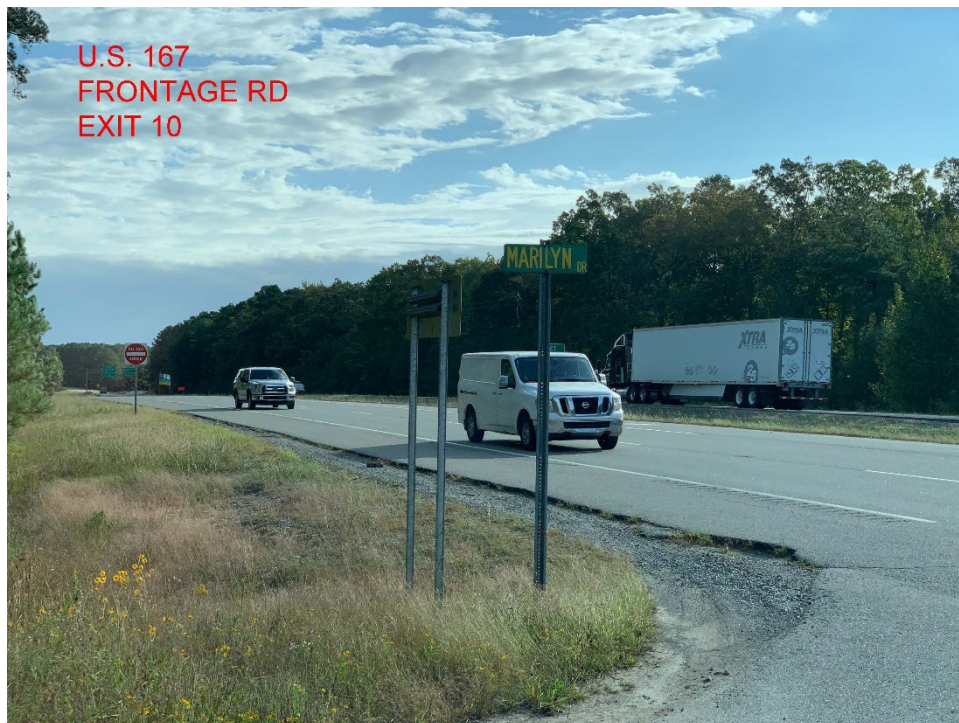
Crash # 2020533237 I-530, Section 1, Direction A, Log Mile 3.658

The interchange at Exit 7 was reviewed. Pavement markings and signs were in place and in conformance with MUTCD. However, the 36"x36" Stop, 30"x30" Do Not Enter, and 36"x12" One Way assembly were missing. They were installed to be consistent with current ARDOT requirements on December 16, 2021.

The interchange at Exit 9 was reviewed. Pavement markings and signs were in place and in conformance with MUTCD. However, the 36"x12" One Way signs were missing but were installed to be consistent with current ARDOT requirements on December 16, 2021.

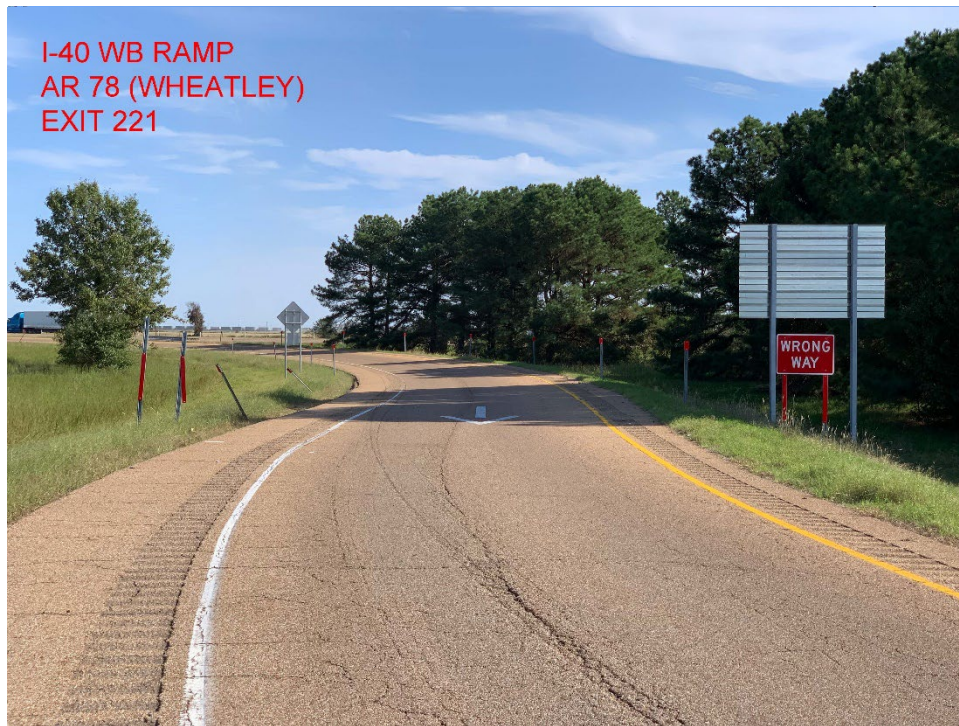
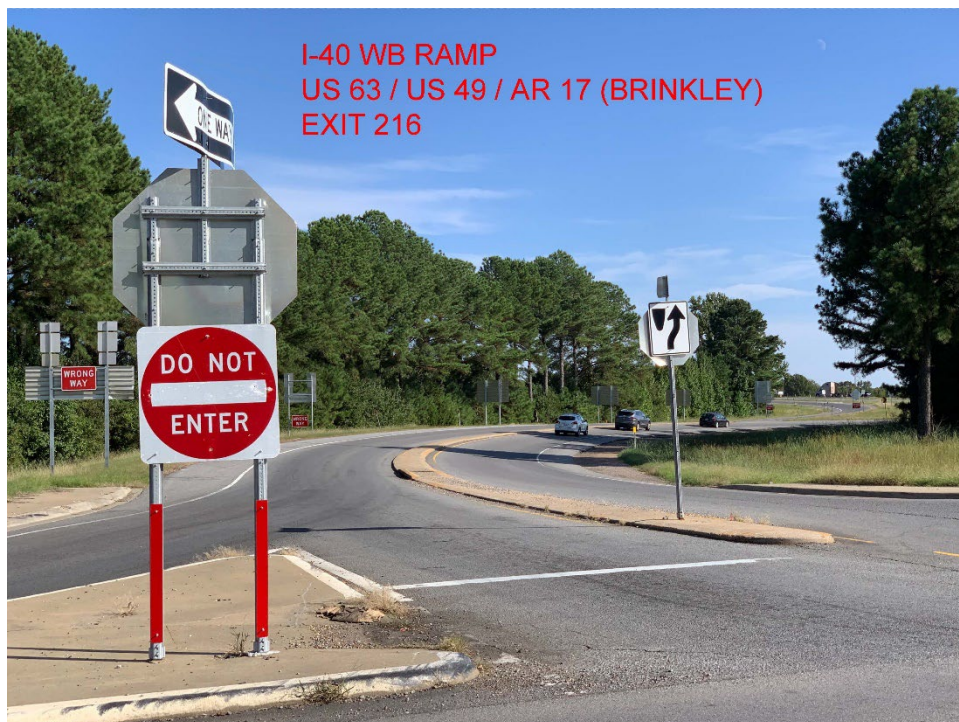
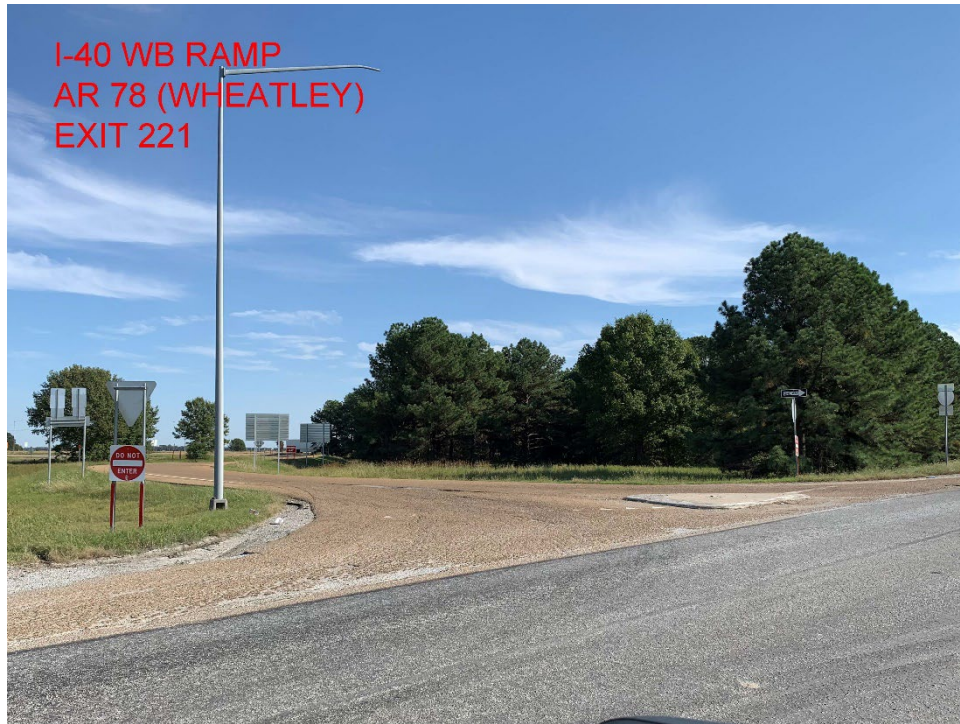
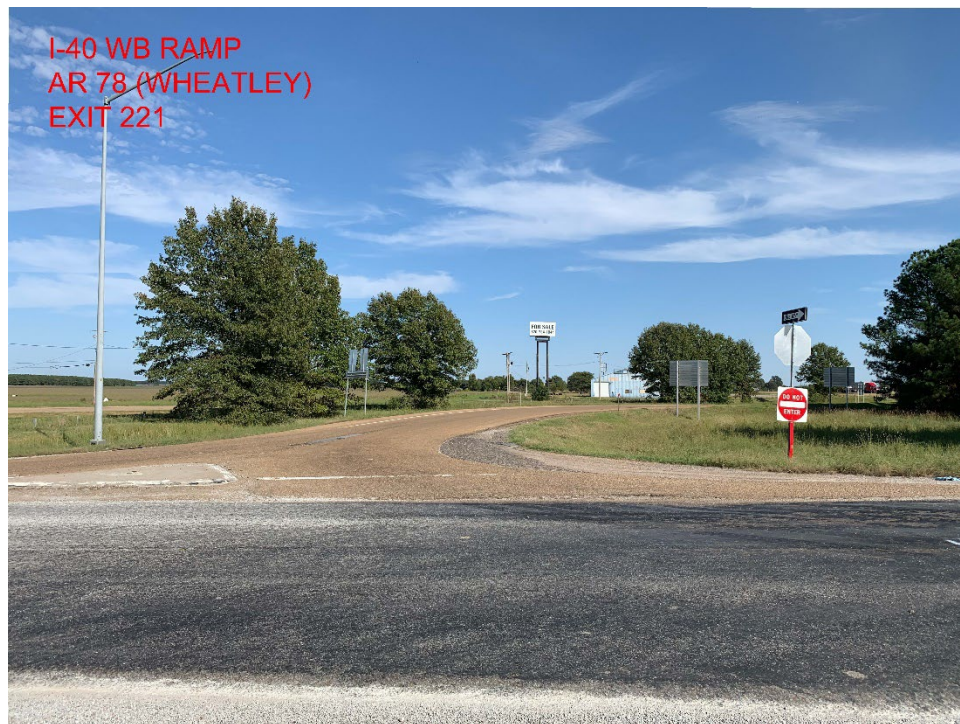
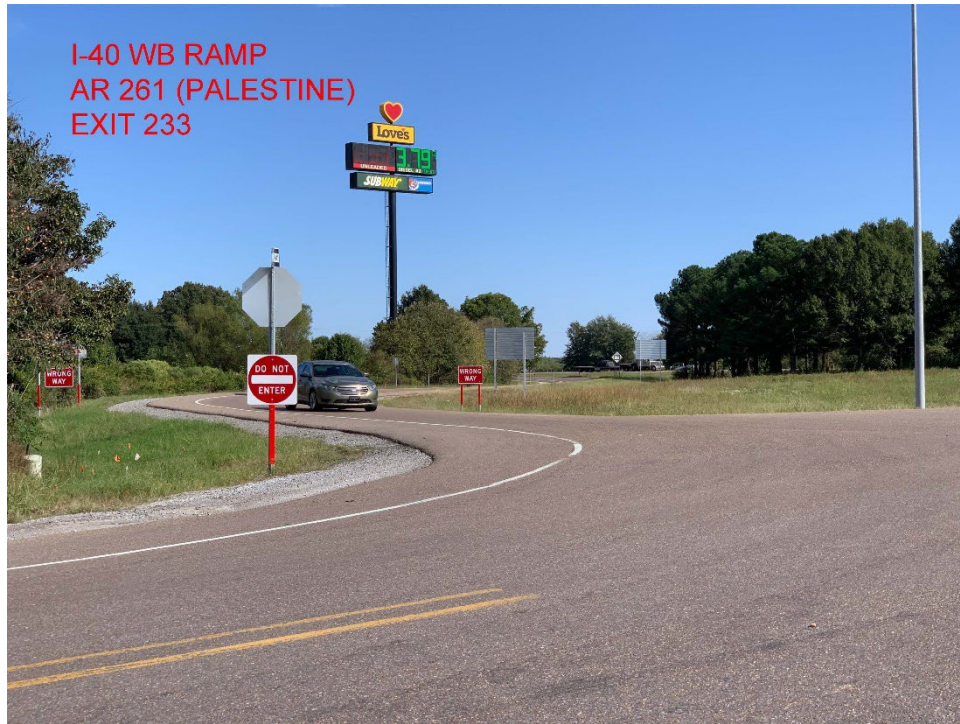
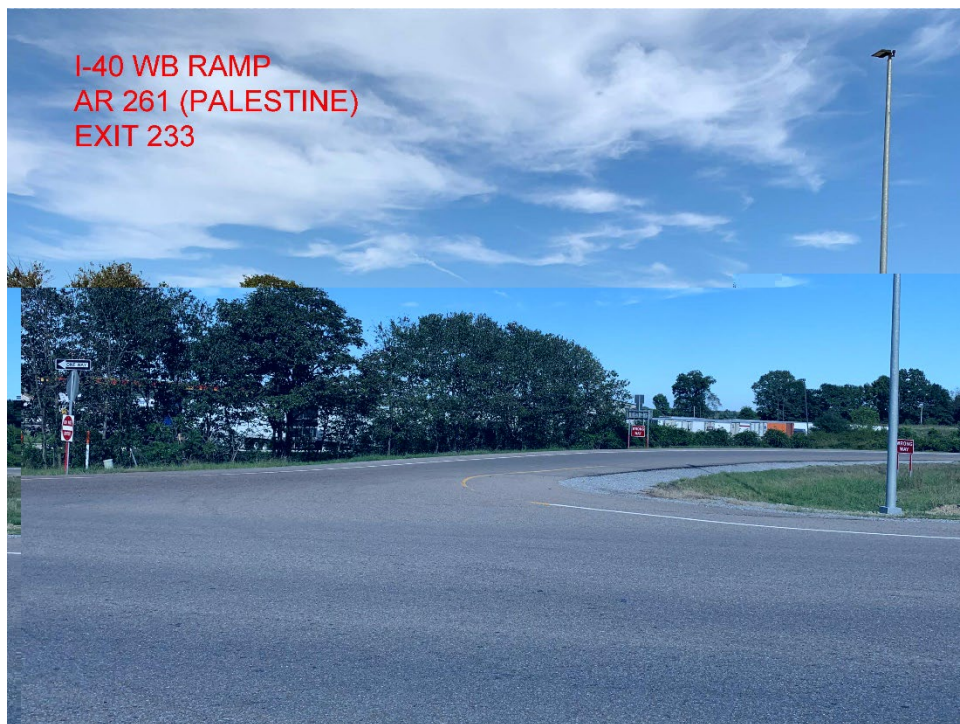
Crash # 2020535673 I-40, Section 51 Direction B, Log Mile 46.016

The interchange at Exit 221 was reviewed. Signs were in place and in conformance with MUTCD. However, the 30"x30" Do Not Enter, 36"x36" Stop, 36"x12" One Way, and 42"x30" Wrong Way signs needed to be installed and the pavement markings (stop and yield bars) had faded and needed to be replaced to be consistent with current ARDOT requirements. These modifications were implemented on February 14, 2022.

The interchange at Exit 233 was reviewed. Signs were in place and in conformance with MUTCD. However, the 30"x30" Do Not Enter, 36"x36" Stop, and 36"x12" One Way signs needed to be installed and the pavement markings (stop bar) needed to be installed to be consistent with current ARDOT requirements. These modifications were implemented on February 14, 2022.

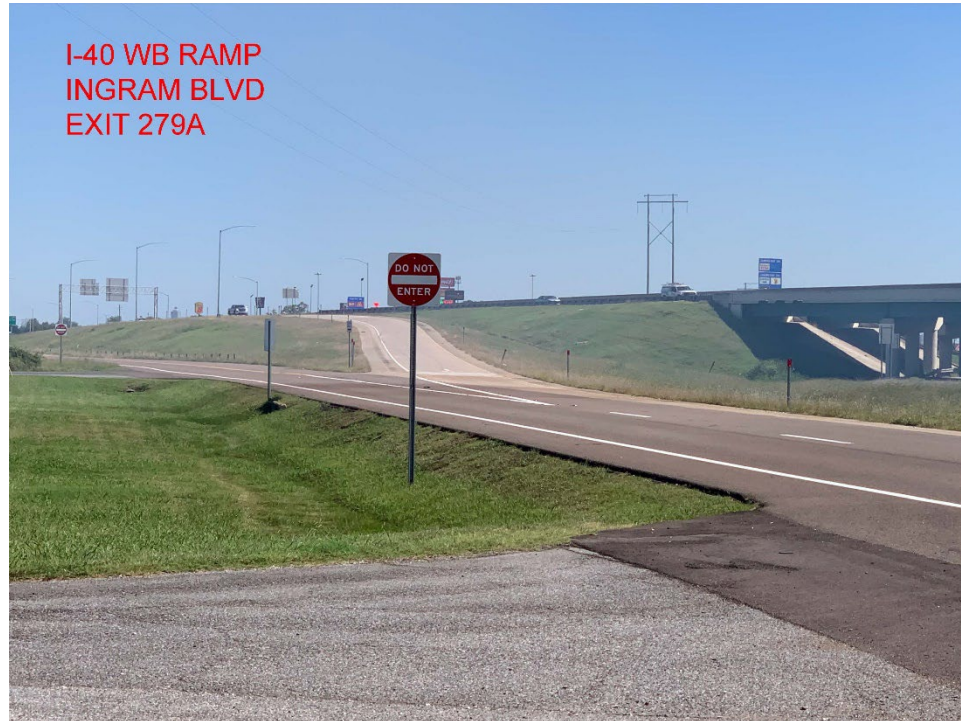
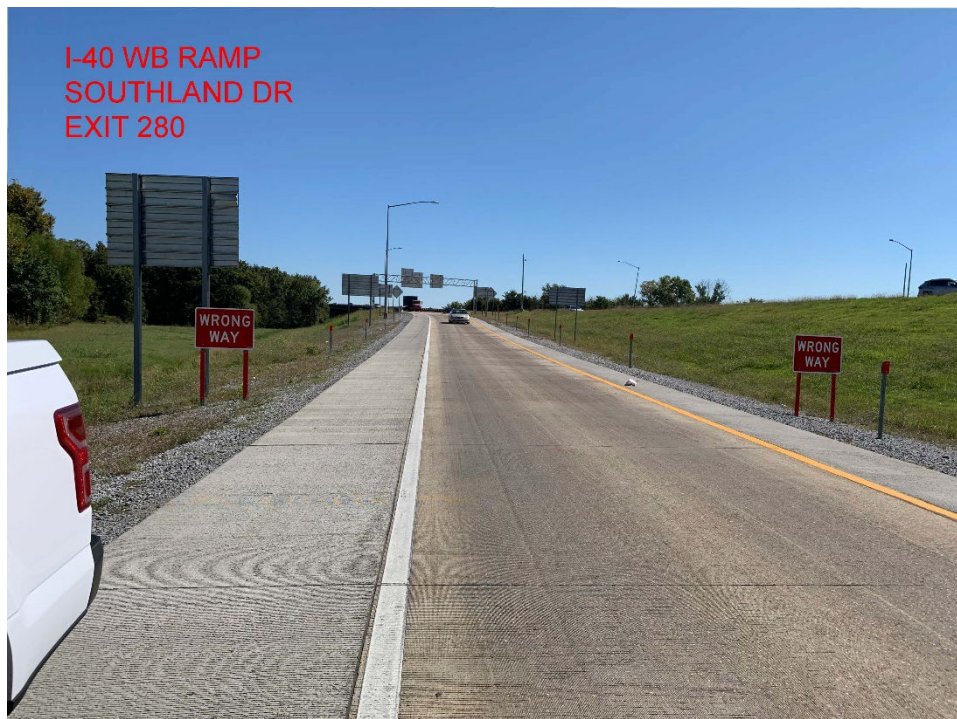
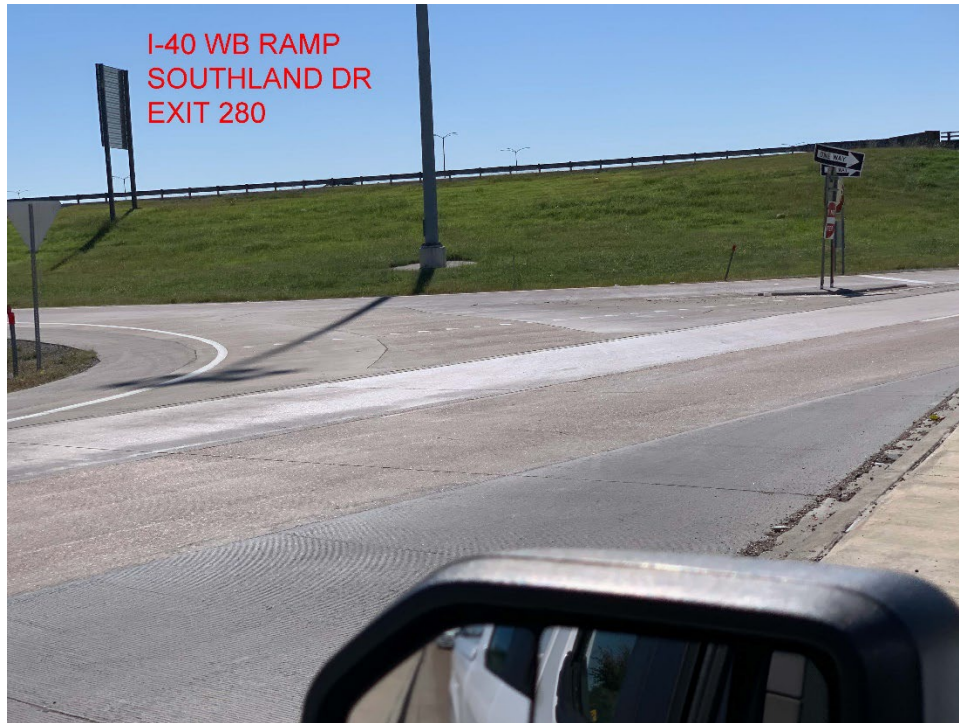
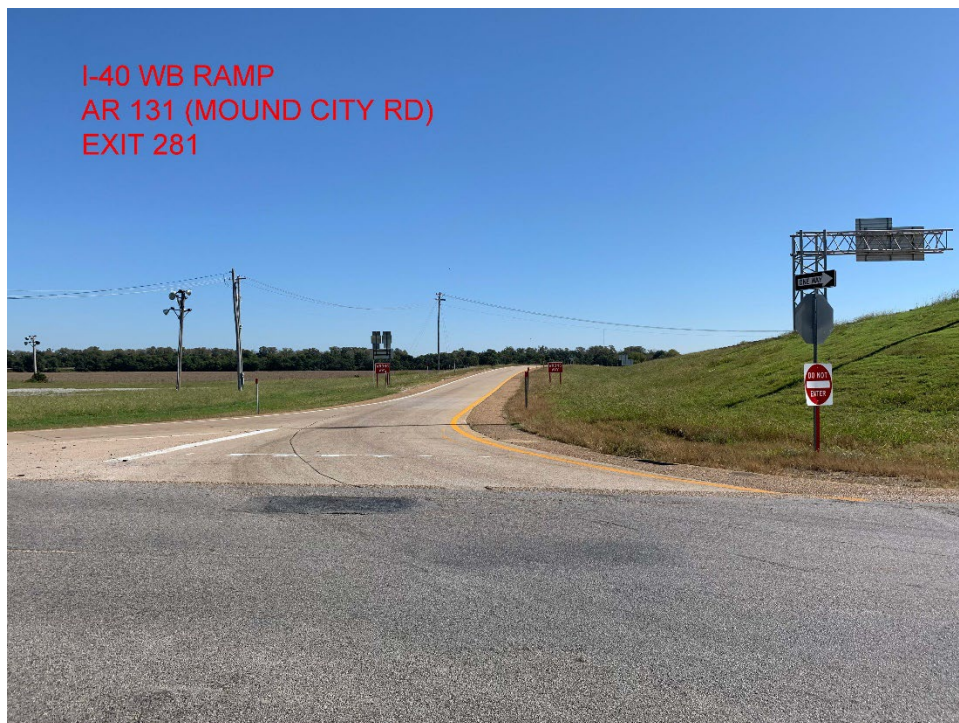
Crash # 2020538156 I-40, Section 52, Direction B, Log Mile 0.417

The interchange at Exit 280 was reviewed. Pavement markings and signs were in place and in conformance with MUTCD requirements. However, the 36"x36" Do Not Enter, 48"x48" Stop, and 54"x18" One Way signs were replaced to be consistent with current ARDOT requirements on February 14, 2022.

The interchange at Exit 281 was reviewed. Signs were in place and in conformance with MUTCD requirements. However, the 30"x30" Do Not Enter, 36"x36" Stop, and 36"x12" One Way signs needed to be installed, the pavement markings (stop bar) had faded, and the pavement marking arrow needed to be moved up 400 ft. to be consistent with current ARDOT requirements. These modifications were implemented on February 14, 2022.
