WRONG-WAY CRASH STUDY

INTERSTATES AND FREEWAYS | CALENDAR YEAR 2020

Published March 2023

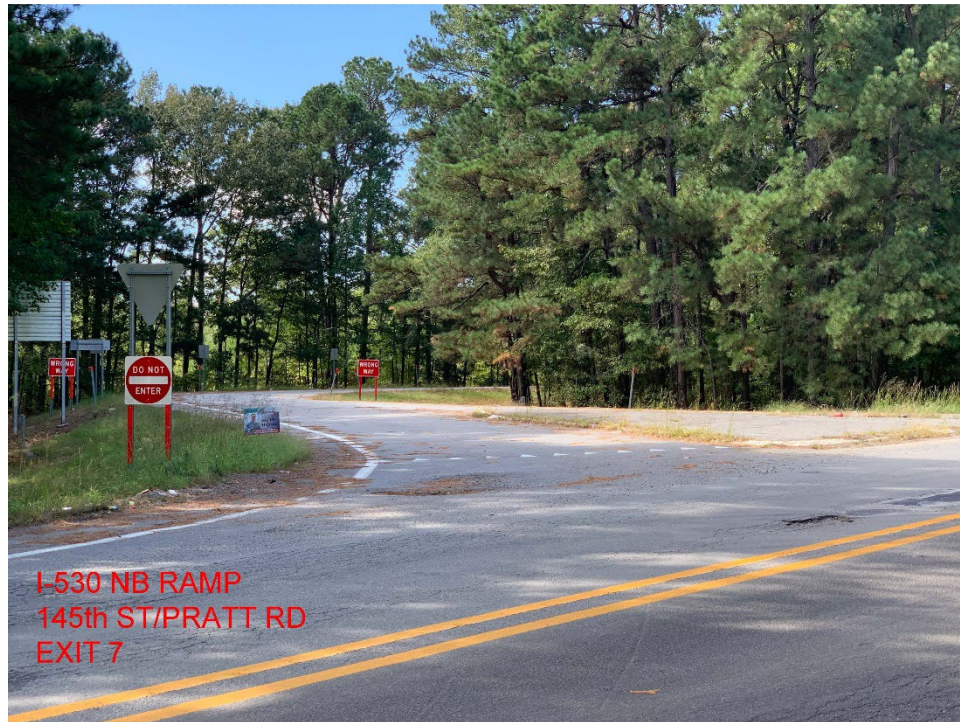
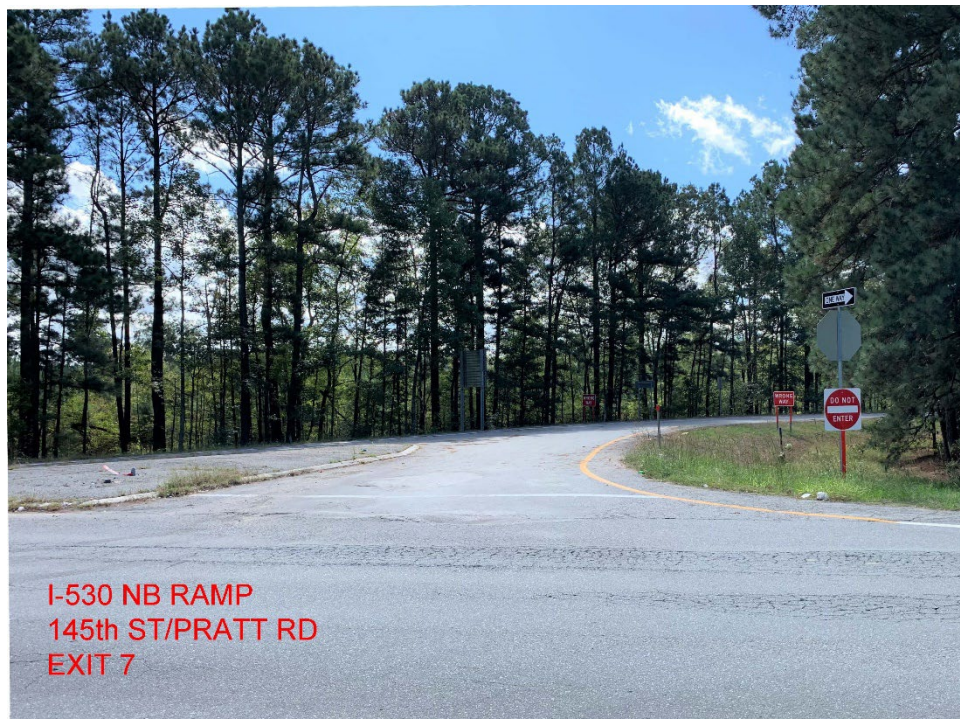
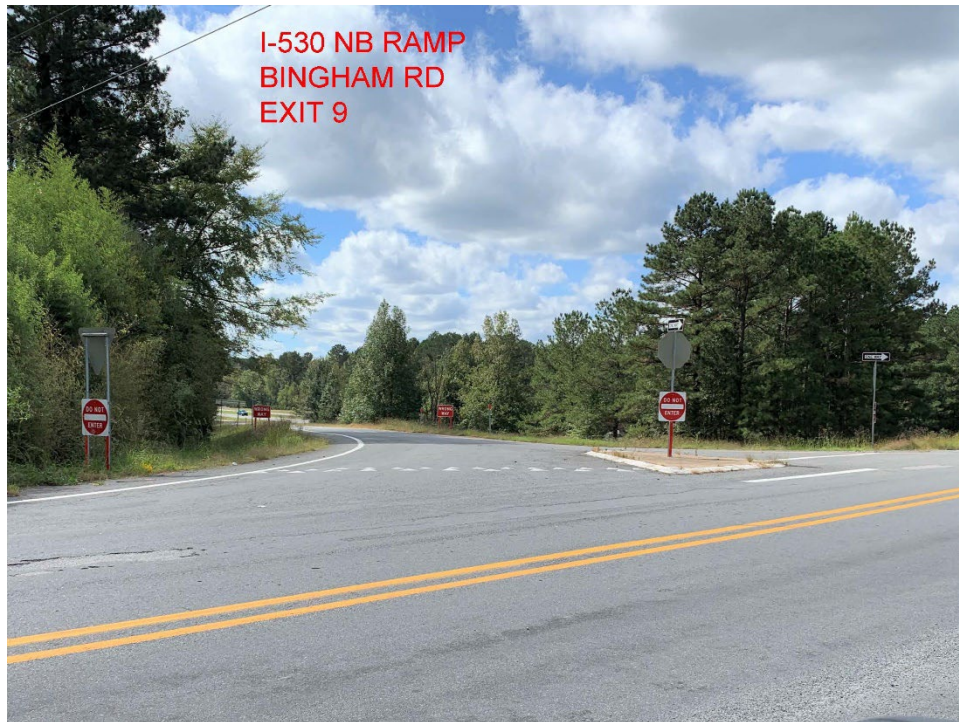
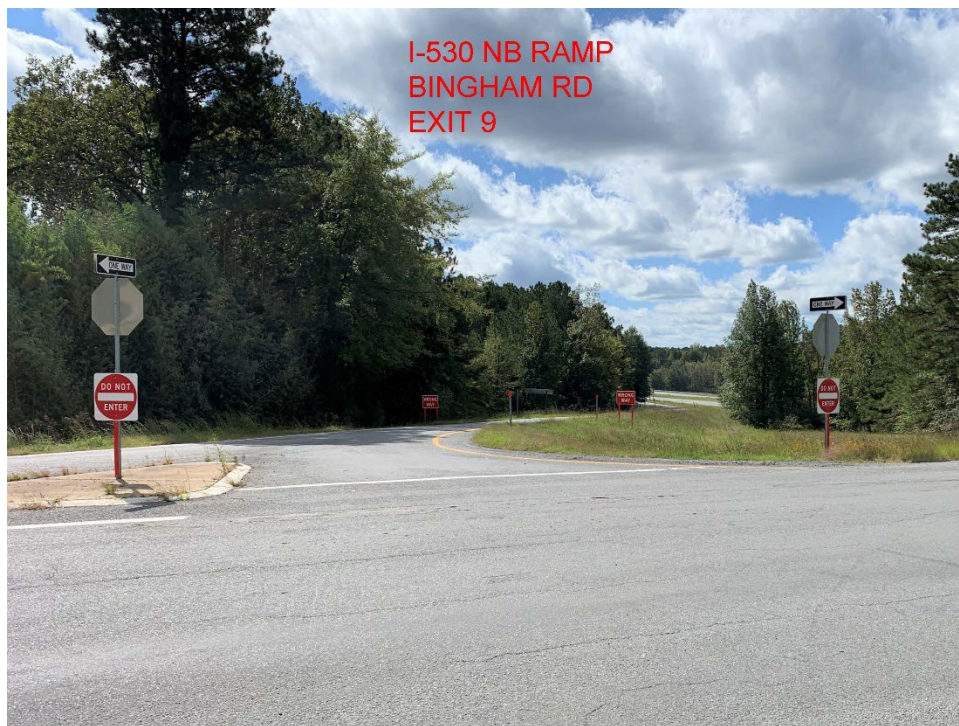
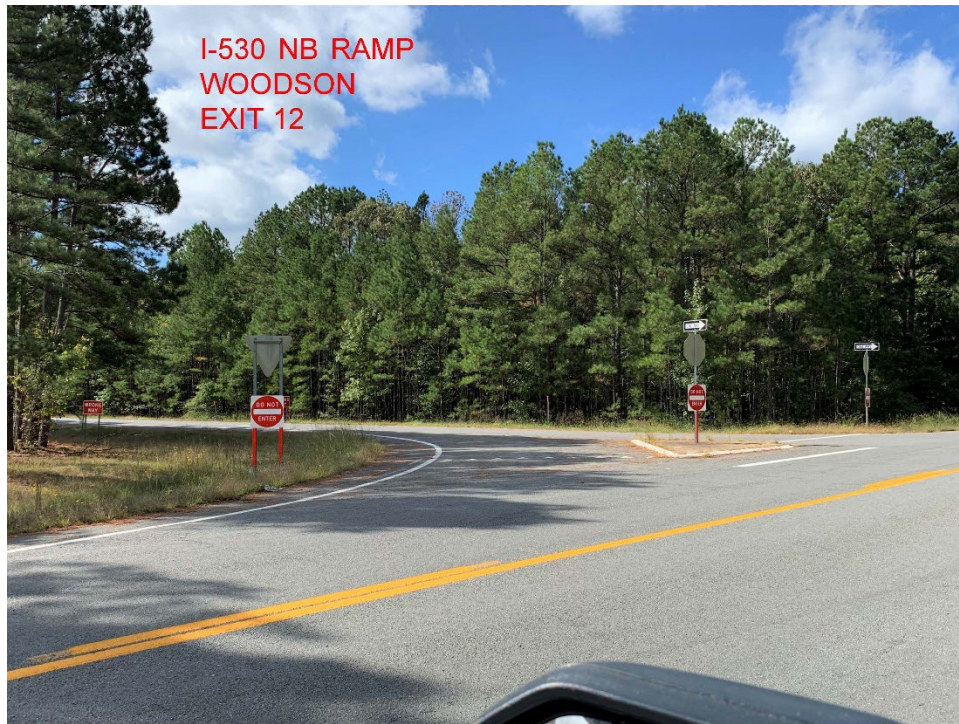
Crash # 2020551450 I-530, Section 3, Direction B, Log Mile 31.804

The interchange at Exit 7 was reviewed. Pavement markings and signs were in place and in conformance with MUTCD. However, the 36"x36" Stop, 30"x30" Do Not Enter, and 36"x12" One Way assembly were missing. They were installed to be consistent with current ARDOT requirements on December 16, 2021.

The interchange at Exit 9 was reviewed. Pavement markings and signs were in place and in conformance with MUTCD. However, the 36"x12" One Way signs were missing but were installed to be consistent with current ARDOT requirements on December 16, 2021.

The interchange at Exit 12 was reviewed. Pavement markings and signs were in place and in conformance with MUTCD and ARDOT standards. However, one of the red vertical reflective strips was missing. It was installed on the "Wrong Way" signpost to be consistent with current ARDOT requirements on December 16, 2021.
