ARKANSAS DEPARTMENT OF TRANSPORTATION

SUBSURFACE INVESTIGATION

STATE JOB NO. 020791

HWYS. 82, 270 & 278 SLIDE REPAIRS (S)

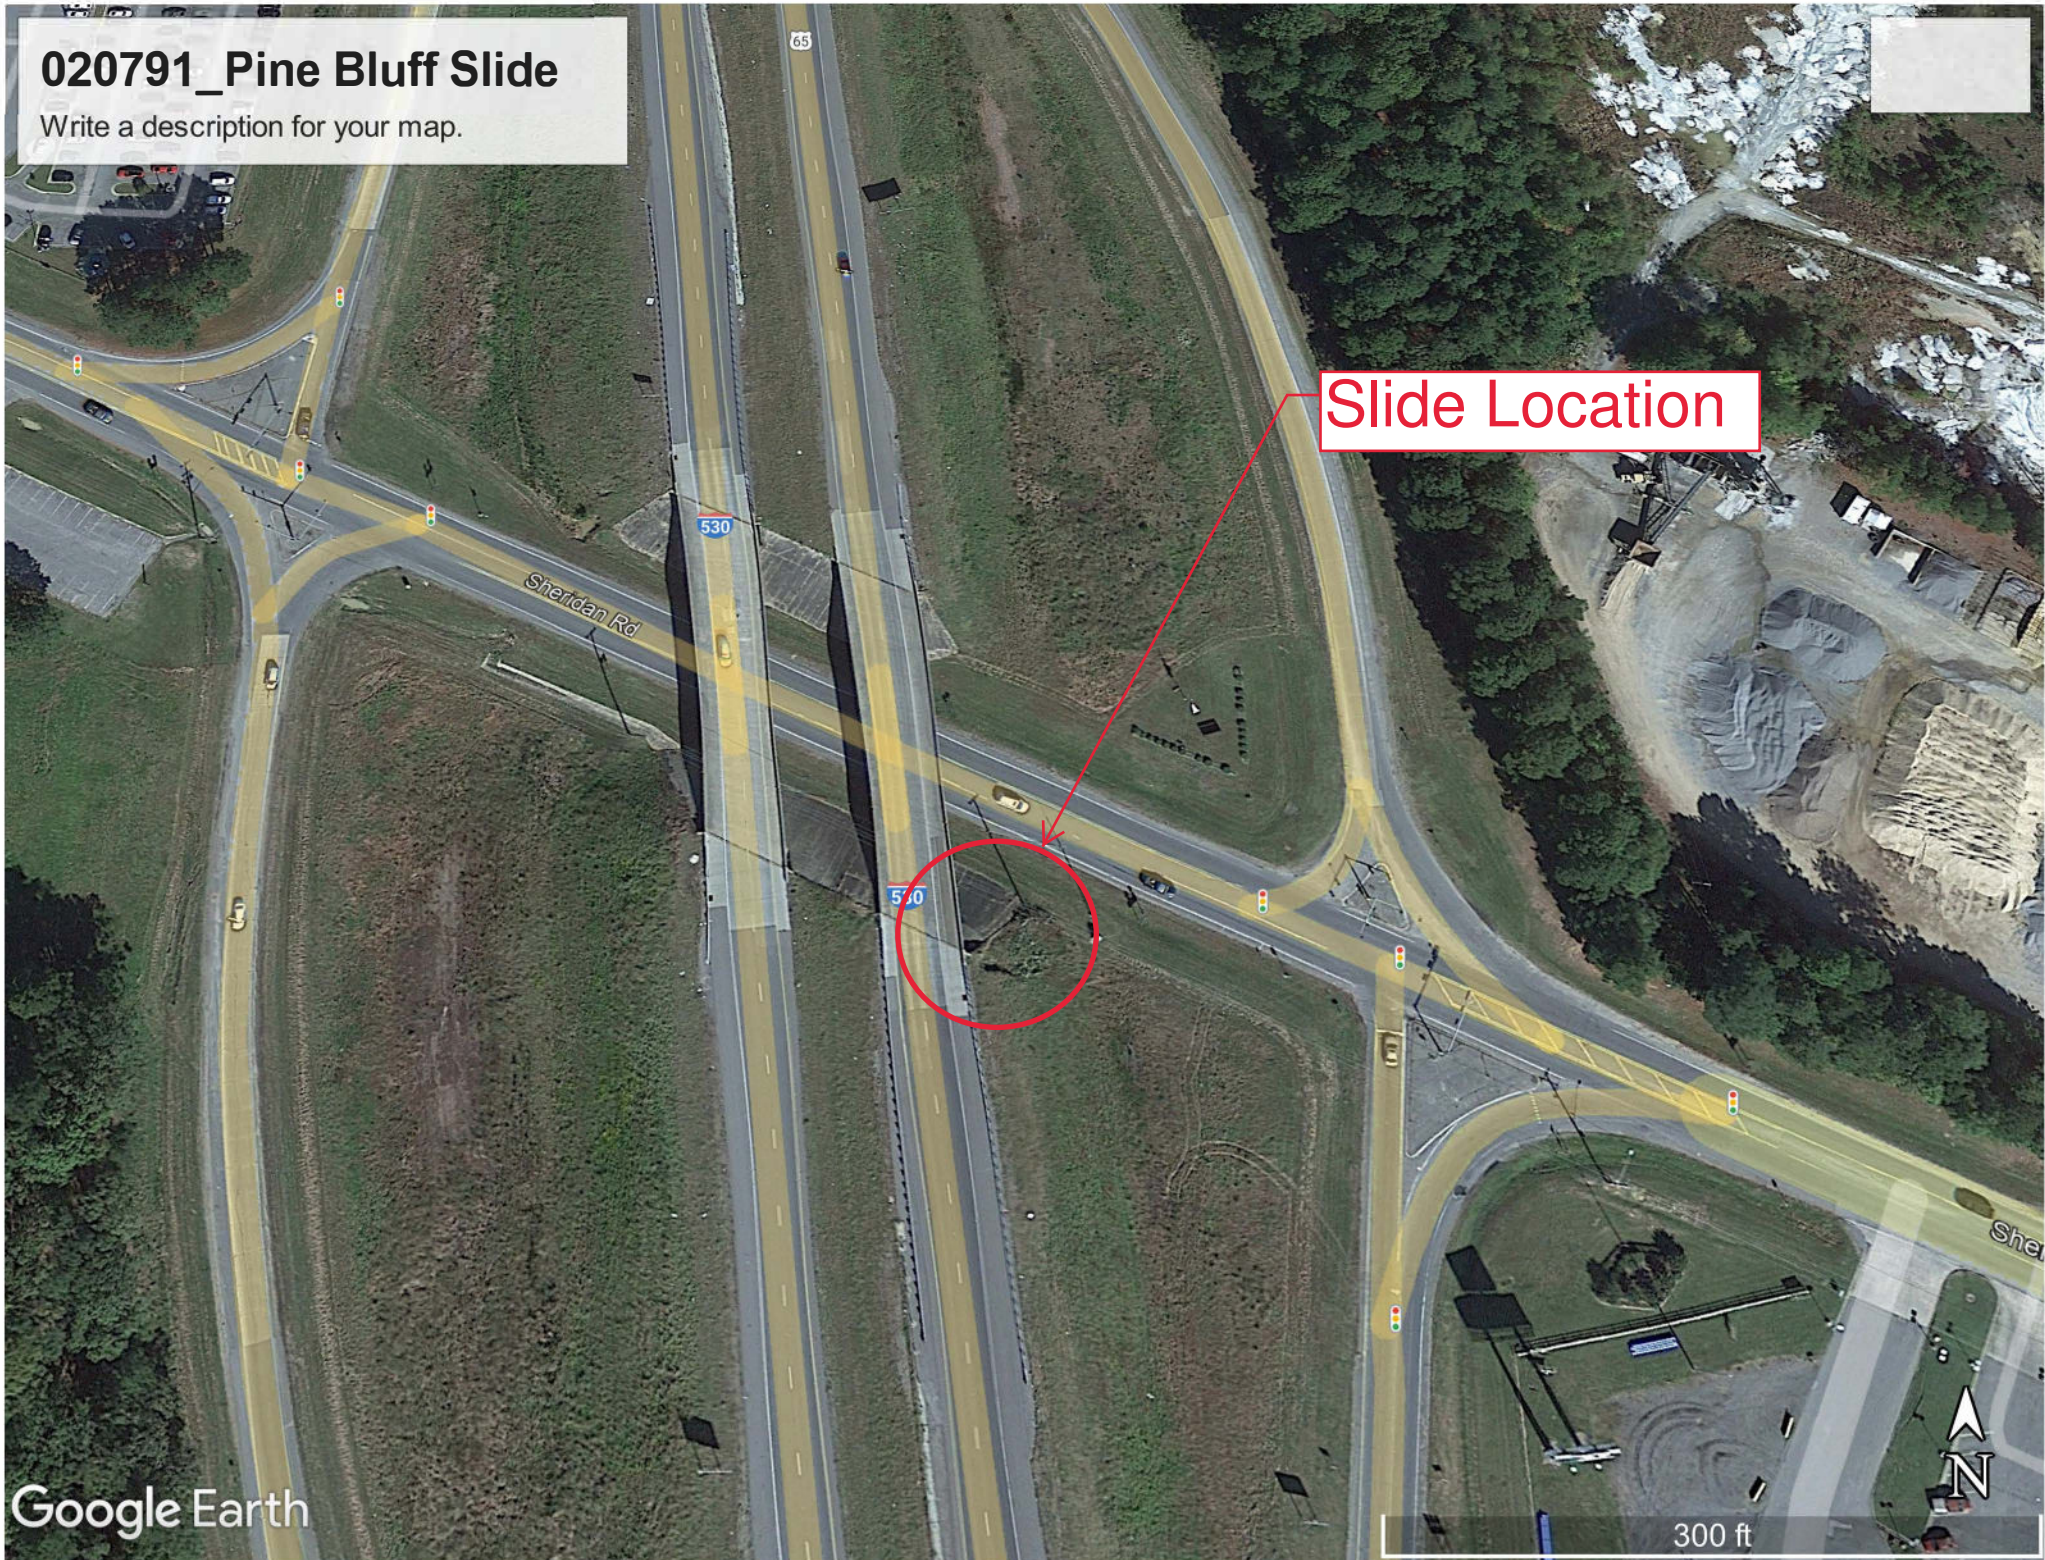
# 020791\_Pine Bluff Slide

Slide Location

### General Repair Recommendations:

See Typical Section for detailed recommendations:
