WRONG-WAY CRASH STUDY

INTERSTATES AND FREEWAYS | CALENDAR YEAR 2020

Published March 2023

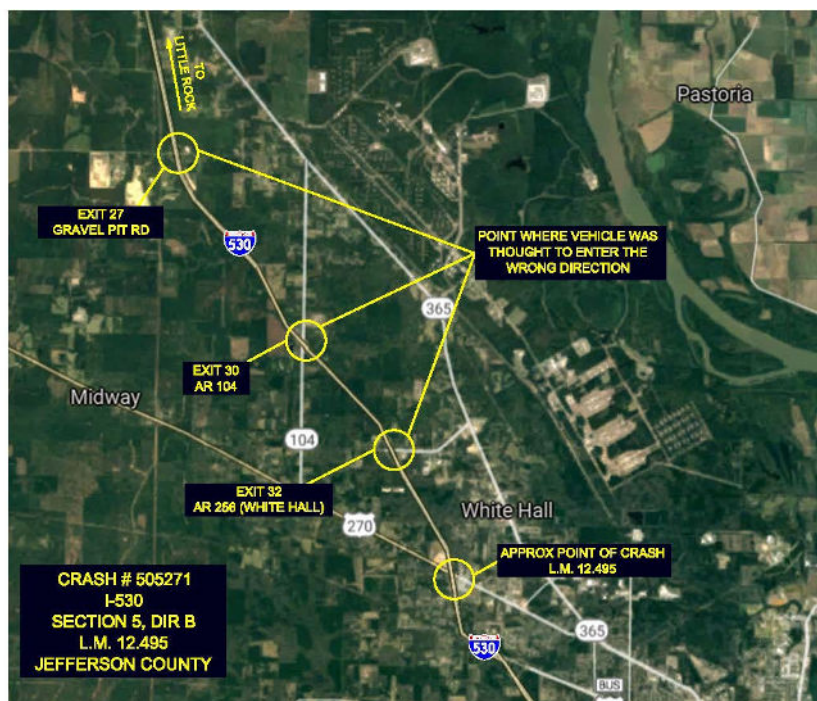
Crash # 2020505271 I-530, Section 5, Direction B, Log Mile 12.495

The driver accessed I-530 possibly at Exit 27 (Gravel Pit Rd.), Exit 30 (AR 104), or Exit 32 (AR 256, White Hall) and traveled southbound in the northbound traffic lane on I-530. The wrong-way driver struck a vehicle in the front bumper and left quarter panel section sheering the left wheel causing it to drag to a stop. The wrong-way driver veered right and struck the cable barrier and damaged five posts. The wrong-way driver was suspected of being under the influence of alcohol.

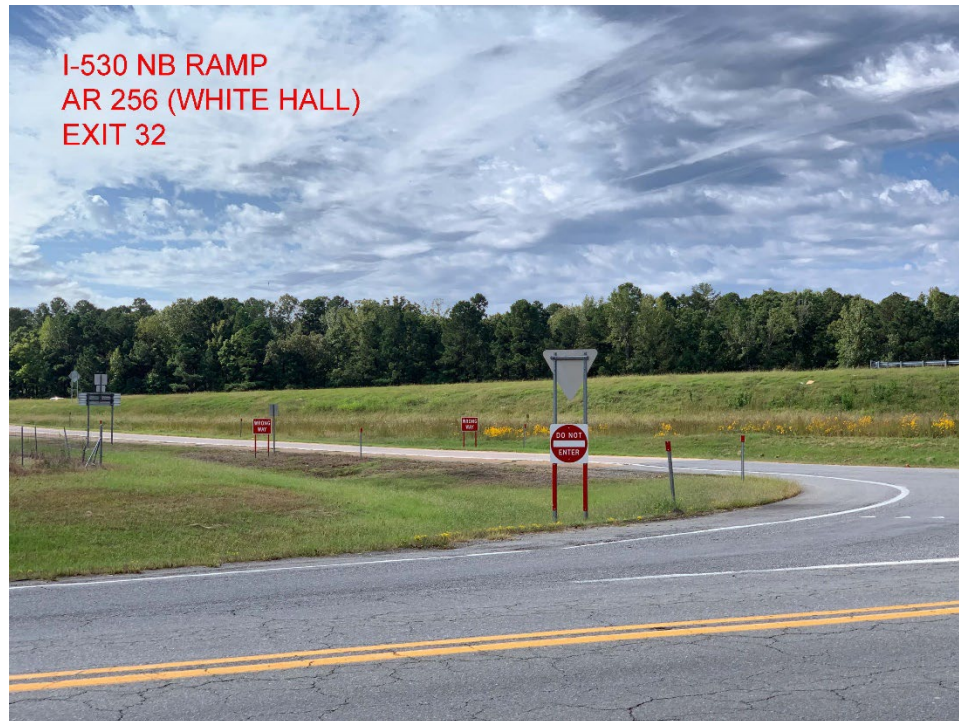
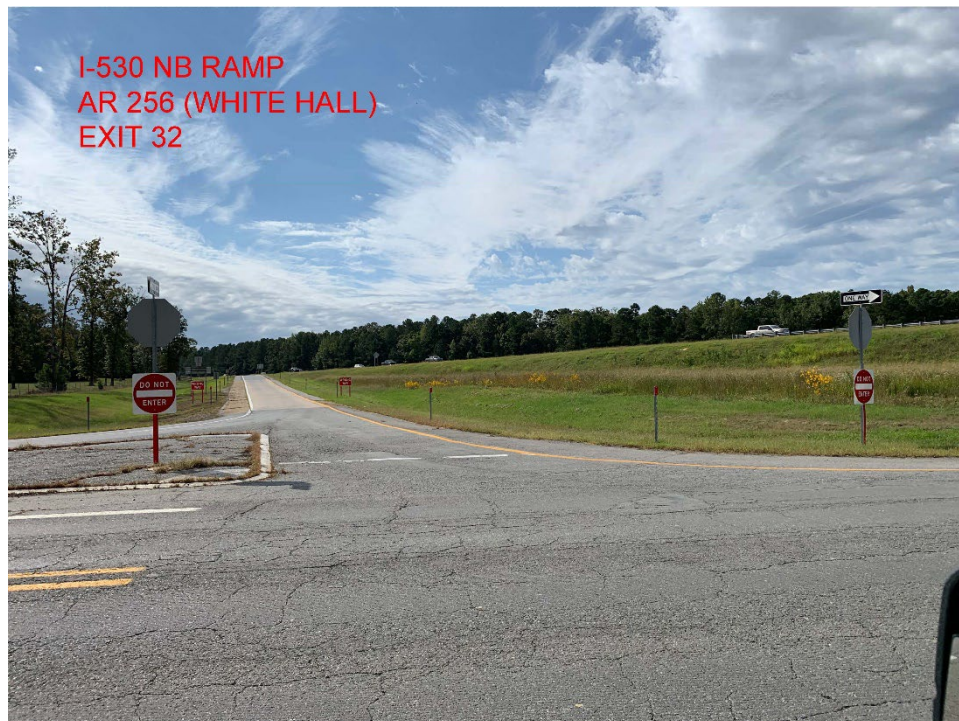
The interchange at Exit 27 was reviewed. Signs were in place and in conformance with MUTCD and ARDOT requirements. However, all pavement markings (stop bar, yield bar, and arrow) had faded and were replaced to be consistent with current ARDOT requirements on March 23, 2022.

The interchange at Exit 32 was reviewed. Signs were in place and in conformance with MUTCD and ARDOT requirement. However, the arrow pavement marking was installed to be consistent with current ARDOT requirements on March 23, 2022.

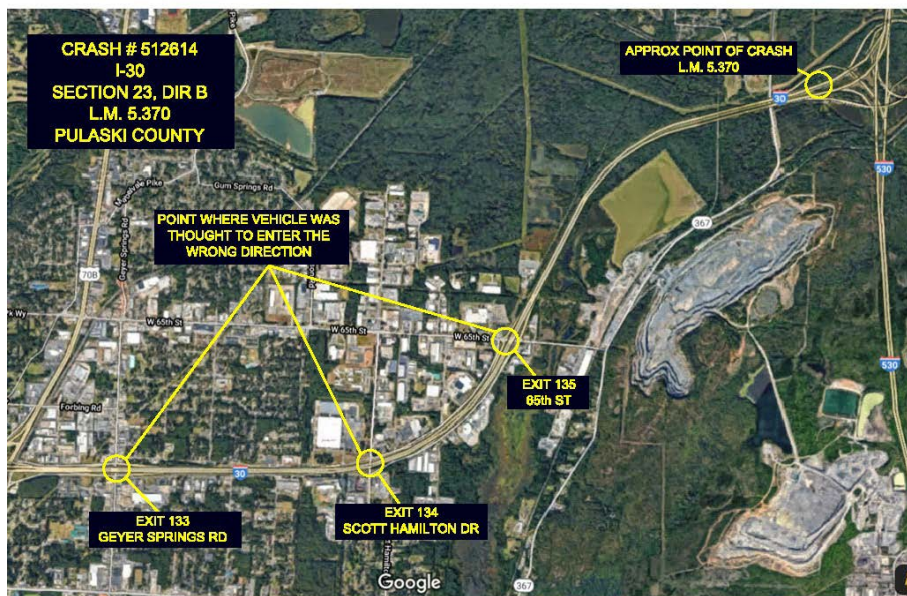
Crash # 2020512614 I-30, Section 23, Direction B, Log Mile 5.370

The driver accessed I-30 possibly at Exit 133 (Geyer Springs Rd.), Exit 134 (Scott Hamilton Dr.), or Exit 135 (65th St.) and traveled eastbound in the westbound traffic lane on I-30. A westbound vehicle attempted to avoid a head-on impact with the wrong-way vehicle by steering to the right. As the wrong-way vehicle passed the westbound vehicle the left side struck the left rear tire of the trailer attached. Following the impact, the wrong-way vehicle traveled off the north side of I-30 and came to rest. The wrong-way driver was determined to be highly intoxicated.

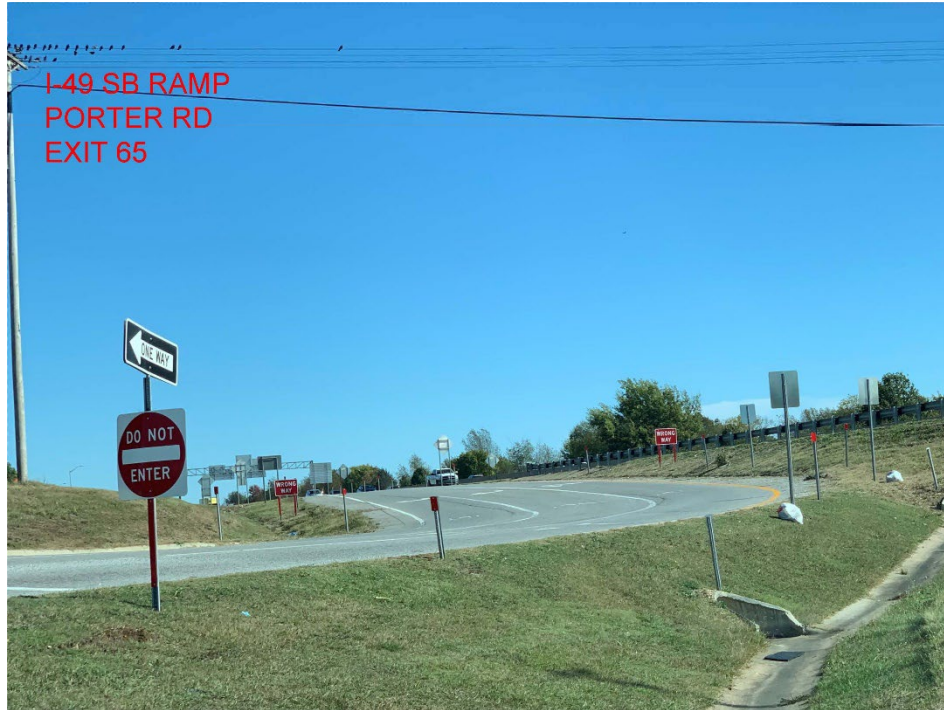
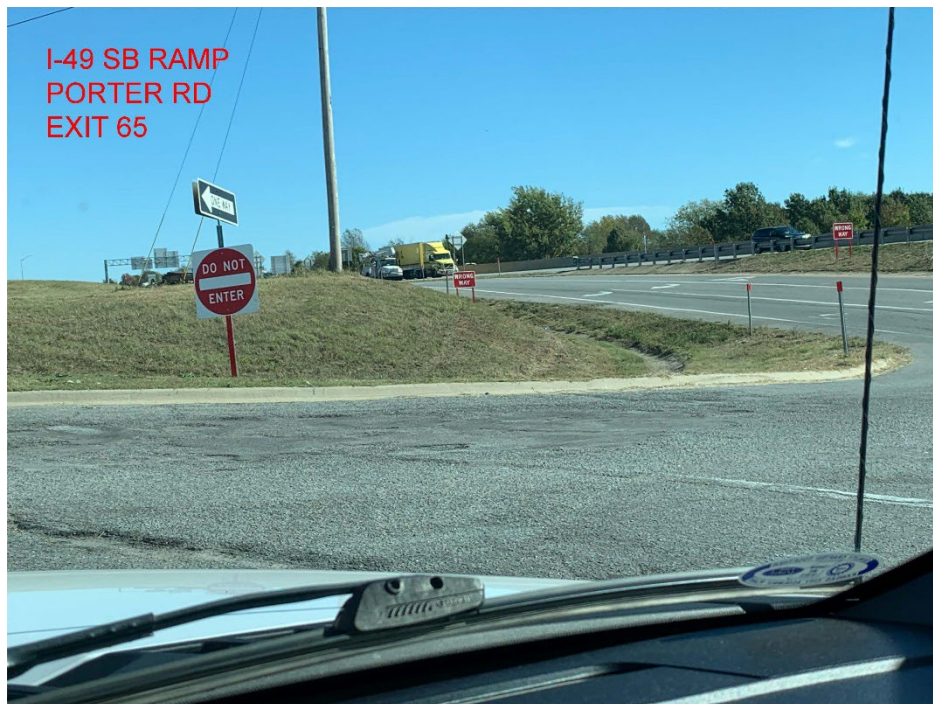
The interchange at Exit 65 was reviewed. Pavement markings and signs were in place and in conformance with MUTCD and ARDOT requirements.

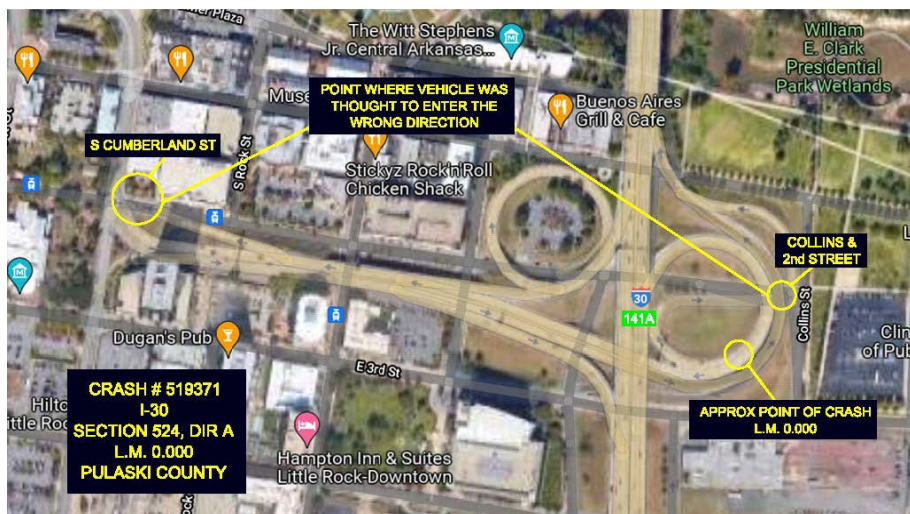
Crash # 2020519371 I-30, Section 524, Direction A, Log Mile 0.000

The driver attempted to access I-30 at S. Cumberland St. or 2nd/Collins St. and traveled northbound in the southbound traffic lane of Exit 141A eastbound off ramp. The wrong-way driver was involved in a head on collision on the I-30 eastbound ramp.

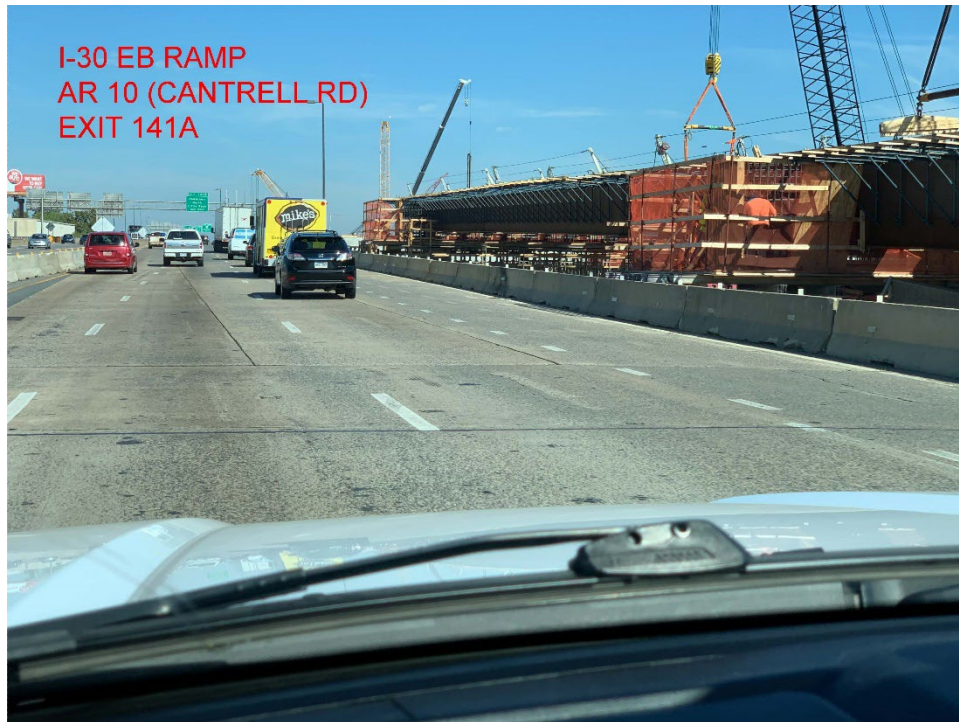
The interchange at Exit 141A was not reviewed because it is closed and being redesigned under the I-30 widening and reconstruction project CA0602.

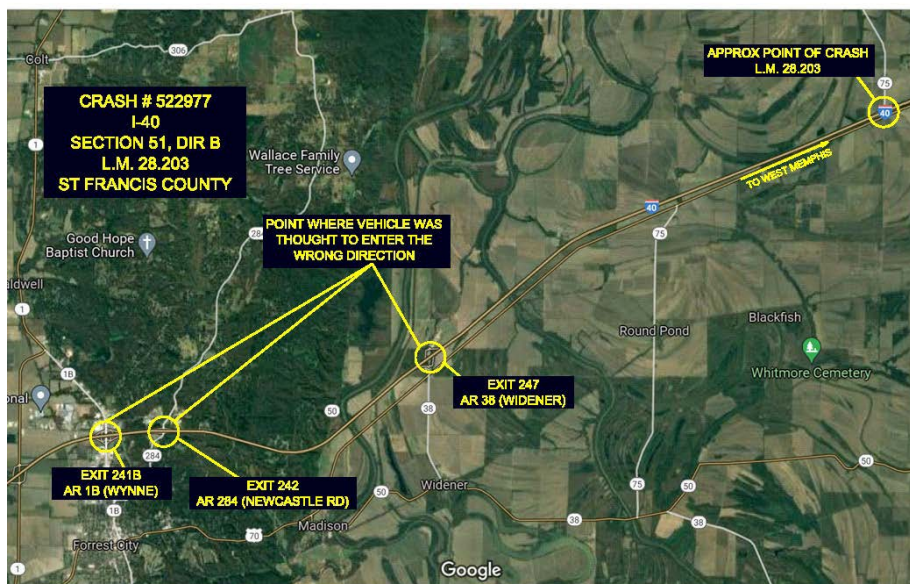
Crash # 2020522977 I-40, Section 51, Direction B, Log Mile 28.203

The driver accessed I-40 possibly at Exit 241B (AR 1B, Wynne), Exit 242 (AR 284, Newcastle Rd.), or Exit 247 (AR 38, Widener) and traveled eastbound in the westbound traffic lane on I-40. The wrong-way driver was involved in a head on collision at log mile 28.203 which caused both vehicles to be completely destroyed by fire. This collision resulted in a fatality for the wrong-way driver.

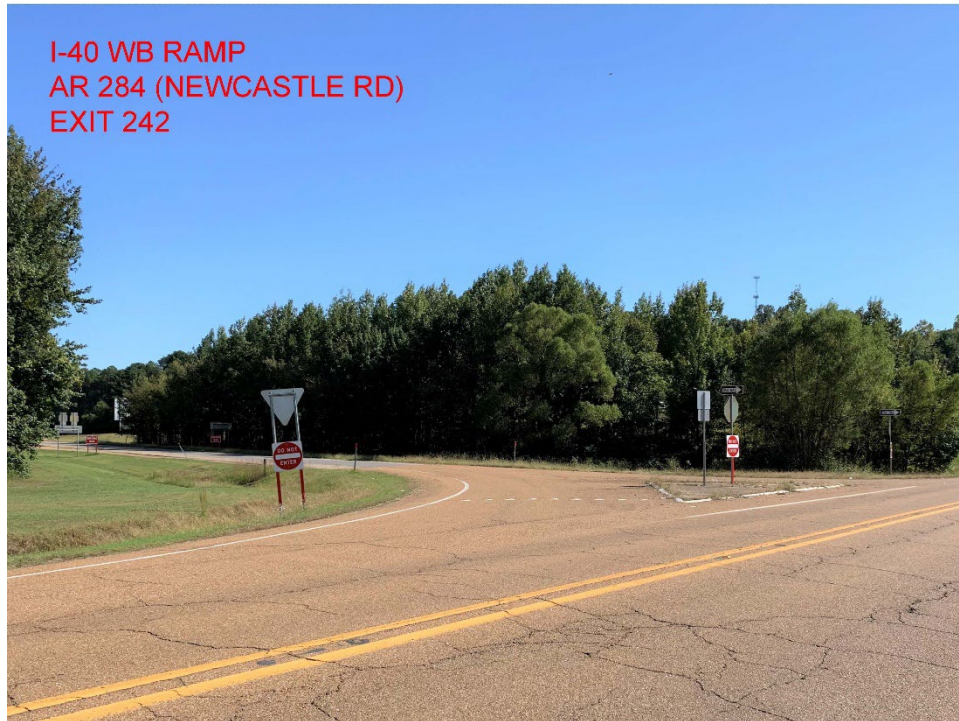
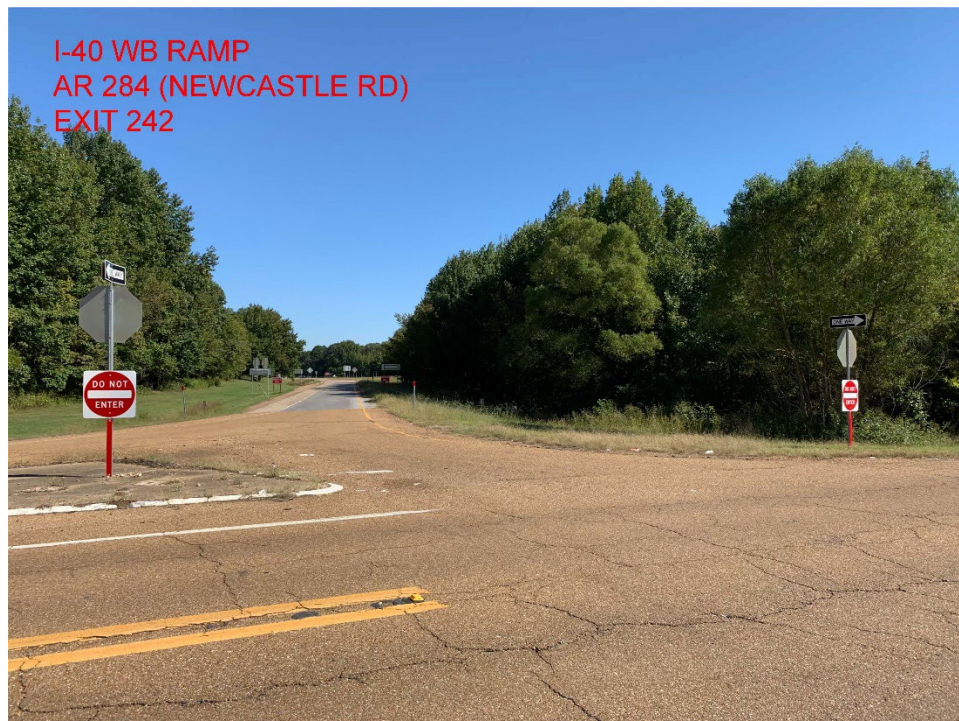
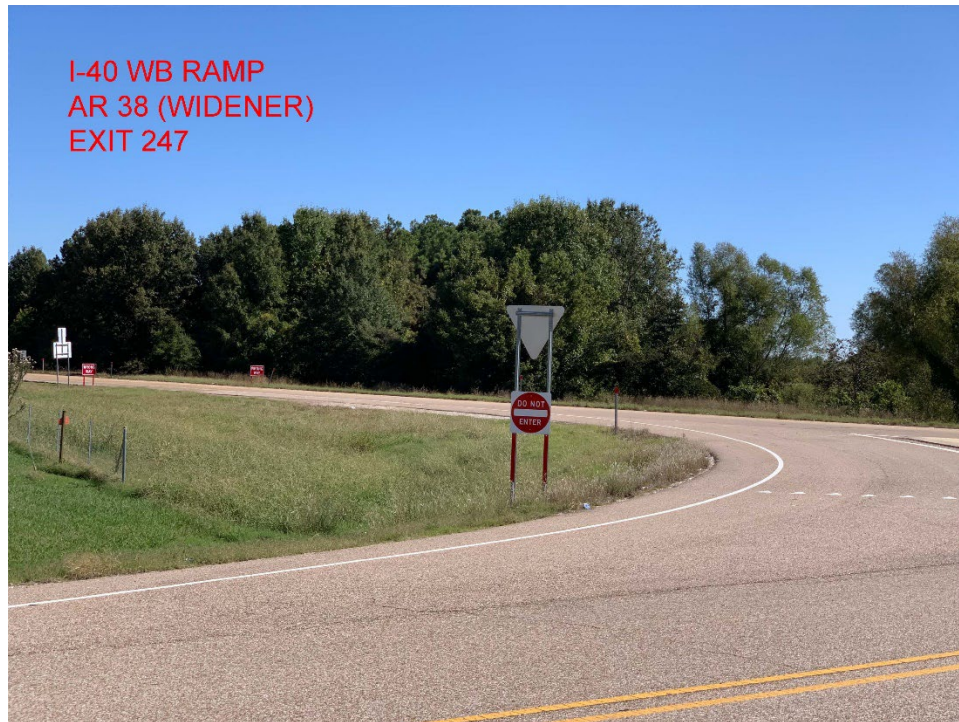
The interchange at Exit 241B was reviewed. Pavement markings and signs were in place and in conformance with MUTCD. However, the 36"x36" Do Not Enter sign was missing but was installed to be consistent with current ARDOT requirements on February 14, 2022.

The interchange at Exit 242 was reviewed. Signs were in place and in conformance with MUTCD and ARDOT requirements. However, the pavement markings (stop bar) had faded and needed to be replaced and the pavement marking arrow needed to be moved up 275 ft. to be consistent with current ARDOT requirements. These modifications were implemented on February 14, 2022.

The interchange at Exit 247 was reviewed. Signs were in place and in conformance with MUTCD and ARDOT requirements. However, the pavement marking arrow needed to be moved up 256 ft. to be consistent with current ARDOT requirements. These modifications were implemented on February 14, 2022.

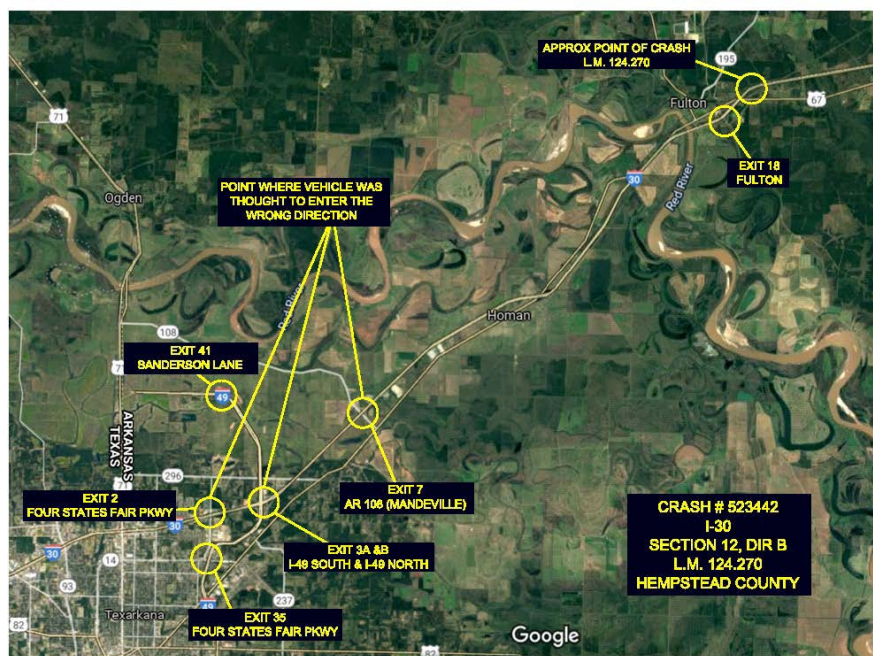
Crash # 2020523442 I-30, Section 12, Direction B, Log Mile 124.270

The driver accessed I-30 possibly at Exit 2 (Four States Fair Pkwy), Exit 41, Exit 35 (I-49 South & I-49 North), or Exit 7 (AR 108, Mandeville) and traveled eastbound in the westbound traffic lane on I-30. The Miller County Sheriff's Department and Hempstead County Sheriff's Office received several calls regarding a white truck that was traveling the wrong-way on the interstate. Miller County Dispatch began receiving calls regarding the vehicle around mile marker 8 westbound. The calls were passed to Hempstead County Dispatch once the vehicle was reported around mile marker 15. The wrong-way vehicle was involved in a head on collision at log mile 18.652 which resulted in a fatality. Both Drivers were pronounced deceased on scene. The wrong-way driver was under the influence of alcohol.

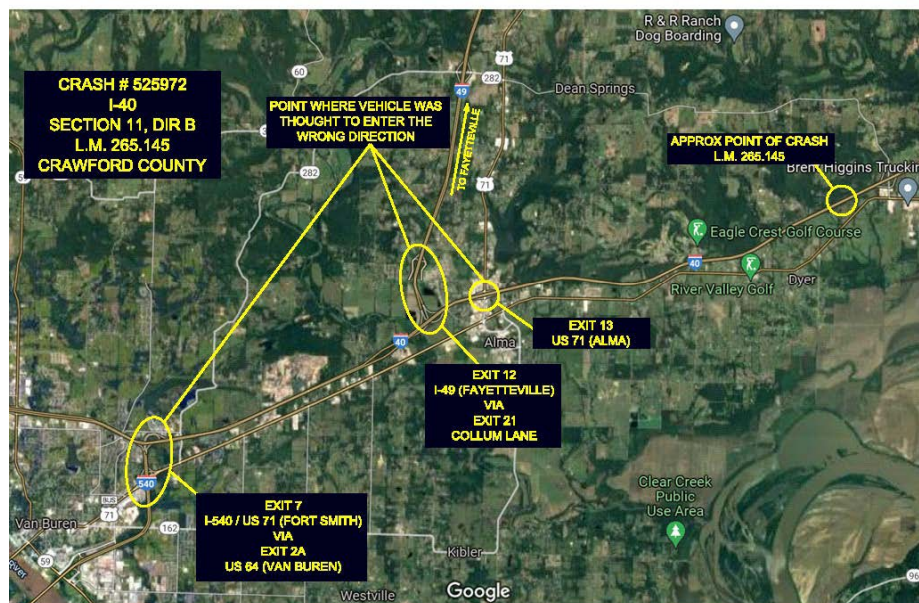
Crash # 2020525972 I-40, Section 11, Direction B, Log Mile 265.145

The driver possibly accessed I-40 at Exit 7 (I-540/US 71, Fort Smith), Exit 12 (I-49, Fayetteville), or Exit 13 (US 71, Alma) and traveled eastbound in the westbound traffic lane on I-40. A westbound driver swerved left to avoid a head on collision and went into the median and struck a highway sign. The wrong-way vehicle continued eastbound and was involved in a head on collision with another westbound vehicle. After impact, the vehicle began rotating clockwise when another westbound vehicle struck the driver side rear trunk area. This impact caused the vehicle to rotate counterclockwise around three times before coming to final rest in the middle of the traffic lanes facing northwest. The wrong-way vehicle driver was suspected of being under the influence of drugs.

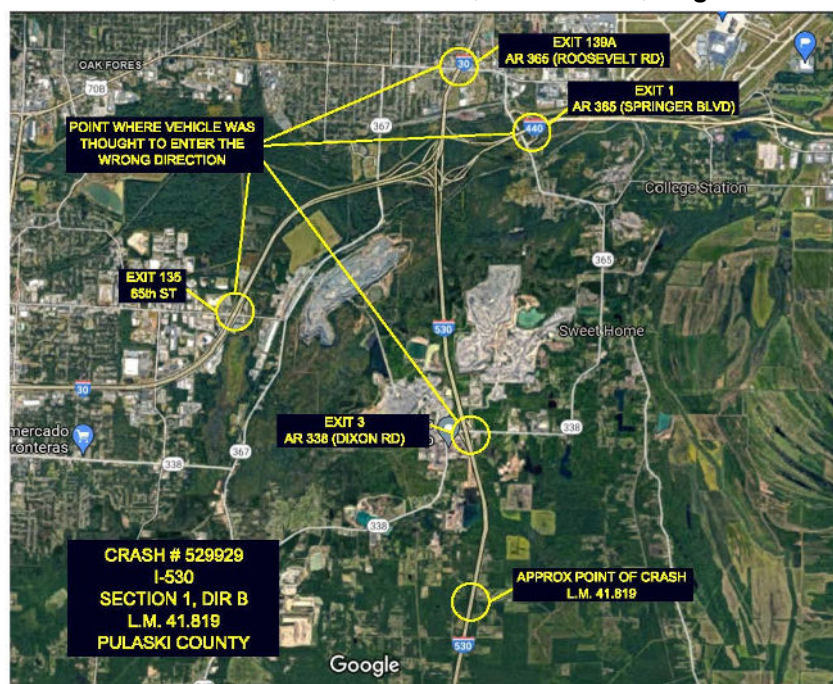
Crash # 2020529929 I-530, Section 1, Direction B, Log Mile 41.819

The driver accessed I-530 possibly at Exit 1 (AR 365, Springer Blvd.), Exit 3 (AR 338, Dixon Rd.), Exit 135 (65th St.), or Exit 139A (AR 365, Roosevelt Rd.) and traveled southbound in the northbound traffic lane on I-530. The wrong-way driver maneuvered her vehicle into the lane of another vehicle and struck the front right bumper causing it to rotate counterclockwise into the west roadside ditch. The impact caused the wrong-way vehicle to travel essentially straight backwards across the number one lane and came to rest on the east roadside shoulder. This collision resulted in a fatality.

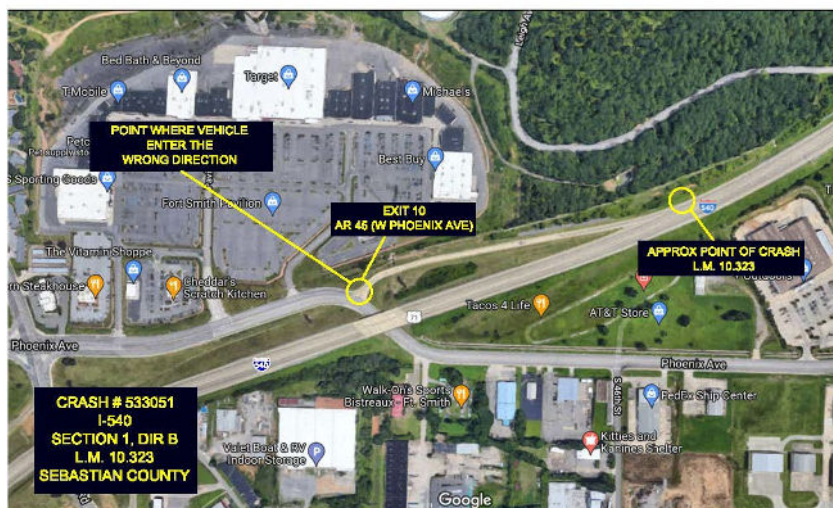
Crash # 2020533051 I-540, Section 1, Direction B, Log Mile 10.323

The driver accessed I-540 at Exit 10 (AR 45, W. Phoenix Ave.) and traveled northbound in the southbound traffic lane on I-540. The driver was involved in a head on collision at log mile 10.323. After impact, both vehicles came to rest on the shoulder. The wrong-way vehicle was involved in two hit and runs before this accident and was suspected of being under the influence of alcohol.

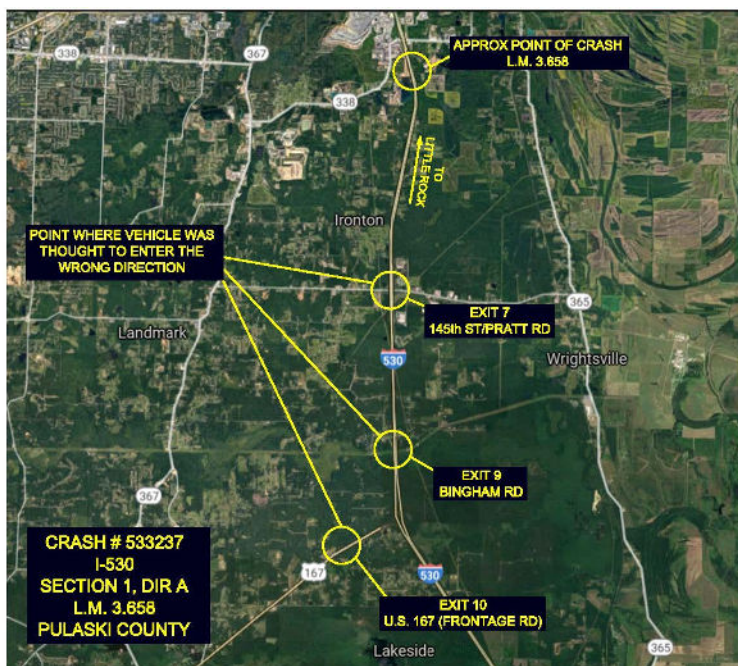
Crash # 2020533237 I-530, Section 1, Direction A, Log Mile 3.658

The driver accessed I-530 possibly at Exit 7 (145th St./Pratt Rd.), Exit 9 (Bingham Rd.) or Exit 10 (U.S. 167 South, Sheridan) and traveled northbound in the southbound traffic lane on I-530. The driver was negotiating a curve and lost control of the vehicle due to intoxication and crossed into lane 1 then exited the right side of the interstate and collided with a standing tree on the passenger's side rear door causing disabling damage.

The interchange at Exit 7 was reviewed. Pavement markings and signs were in place and in conformance with MUTCD. However, the 36"x36" Stop, 30"x30" Do Not Enter, and 36"x12" One Way assembly were missing. They were installed to be consistent with current ARDOT requirements on December 16, 2021.

The interchange at Exit 9 was reviewed. Pavement markings and signs were in place and in conformance with MUTCD. However, the 36"x12" One Way signs were missing but were installed to be consistent with current ARDOT requirements on December 16, 2021.

The interchange at Exit 10 was reviewed. Pavement markings and signs were in place and in conformance with MUTCD and ARDOT requirements.

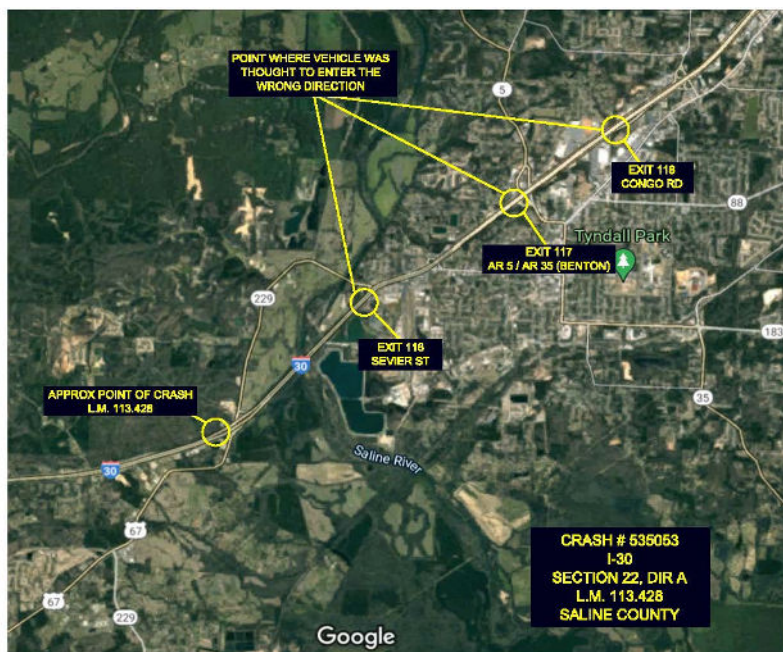
Crash # 2020535053 I-30, Section 22, Direction A, Log Mile 113.428

The driver accessed I-30 possibly at Exit 116 (Sevier St.), Exit 117 (AR 5 / AR 35, Benton), or Exit 118 (Congo Rd.) and traveled westbound in the eastbound traffic lane on I-30. The right front portion of the wrong-way vehicle struck the right front of an eastbound vehicle. The eastbound vehicle left front portion then struck the concrete barrier in the median. The wrong-way vehicle came to rest in the number one traffic lane. The wrong-way driver was suspected of being under the influence of alcohol.

The interchange at Exit 117 was reviewed. Pavement markings and signs were in place and in conformance with MUTCD requirements. However, an additional 36"x36" Do Not Enter sign was installed at the entrance ramp and other 30"x30" Do Not Enter signs were upsized to 36"x36" with their posts delineated with the red vertical reflective strips to be consistent with current ARDOT requirements on December 15, 2021.

The interchange at Exit 118 was reviewed. Pavement markings and signs were in place and in conformance with MUTCD requirements. However, an additional 36"x36" Do Not Enter sign was installed at the entrance ramp and other 30"x30" Do Not Enter signs were upsized to 36"x36" with their posts delineated with the red vertical reflective strips to be consistent with current ARDOT requirements on December 15, 2021.

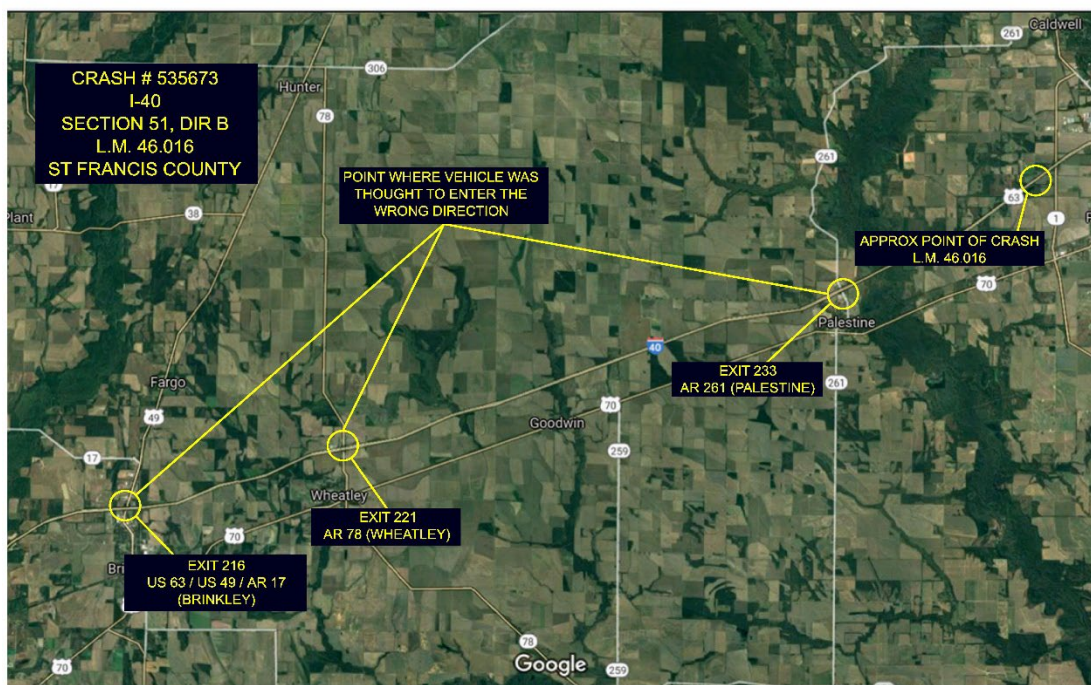
Crash # 2020535673 I-40, Section 51 Direction B, Log Mile 46.016

The driver accessed I-40 possibly at Exit 216 (US 63 / US 49 / AR 17, Brinkley), Exit 221 (AR 78, Wheatley), or Exit 233 (AR 261, Palestine) and traveled eastbound in the westbound traffic lane on I-40. The driver was in a head on collision with a tractor-trailer which resulted in a fatality. The wrong-way driver was suspected of drug usage.

The interchange at Exit 221 was reviewed. Signs were in place and in conformance with MUTCD. However, the 30"x30" Do Not Enter, 36"x36" Stop, 36"x12" One Way, and 42"x30" Wrong Way signs needed to be installed and the pavement markings (stop and yield bars) had faded and needed to be replaced to be consistent with current ARDOT requirements. These modifications were implemented on February 14, 2022.

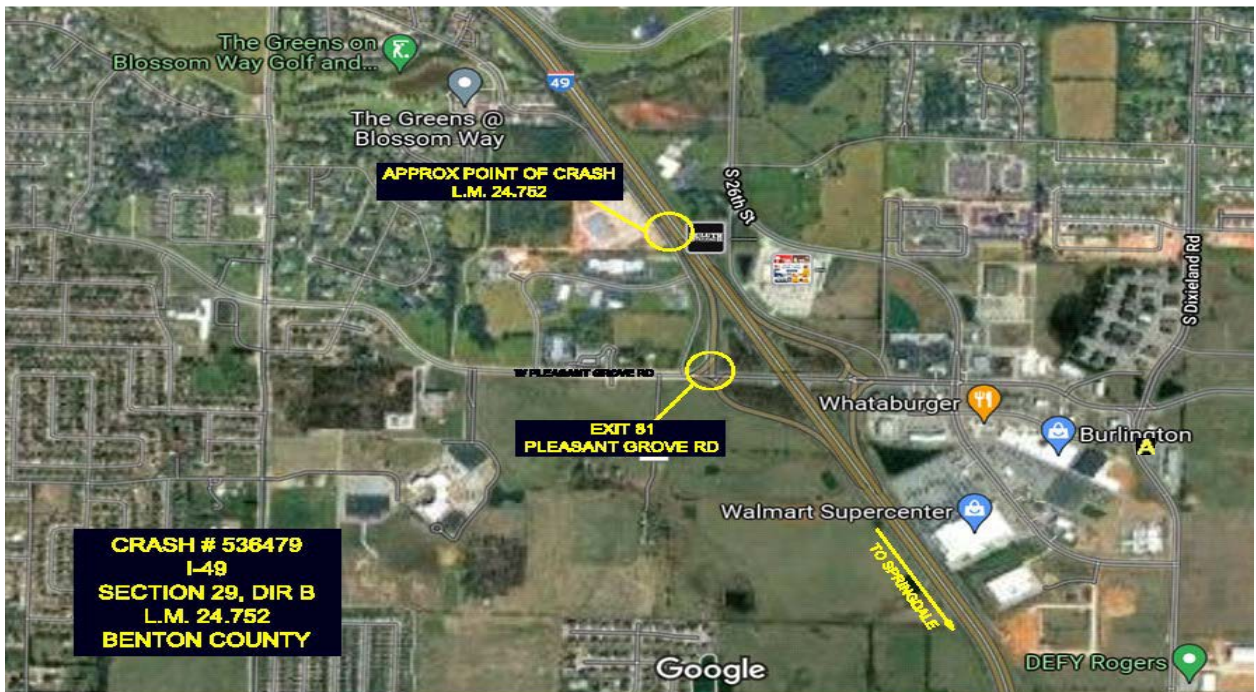
Crash # 2020536479 I-49, Section 29, Direction B, Log Mile 24.752

The driver accessed I-49 at Exit 81 (Pleasant Grove Rd.) and traveled northbound in the southbound traffic lane on I-49. The front passenger side of the wrong-way vehicle struck the front passenger side of a southbound vehicle. The impact caused the front of both vehicles to go into the air. The wrong-way vehicle landed facing south and the other vehicle landed facing east. Another southbound vehicle was unable to stop and struck the back and caused them to spin clockwise. This accident caused a fatal for the passenger of the wrong-way vehicle. The wrong-way driver was under the influence of alcohol and drugs.

The interchange at Exit 81 was reviewed. Pavement markings and signs were in place and in conformance with MUTCD and ARDOT requirements.

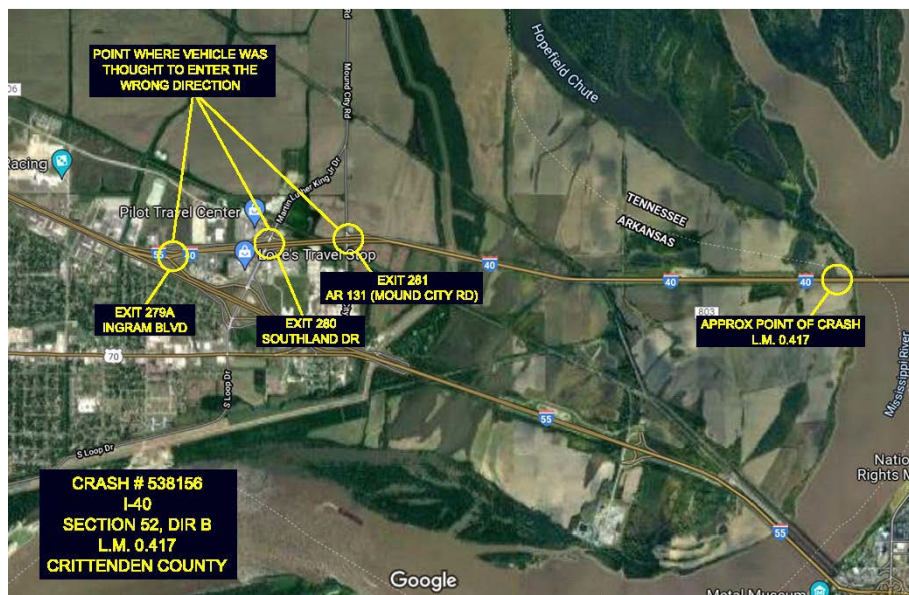
Crash # 2020538156 I-40, Section 52, Direction B, Log Mile 0.417

The driver accessed I-40 possibly at Exit 279A (Ingram Blvd.), Exit 280 (Southland Dr.), or Exit 281 (AR 131, Mound City Rd.) and traveled eastbound in the westbound traffic lane on I-40. The wrong-way vehicle was being pursued by the Crittenden County Sheriff's Department for allegedly committing criminal activities in the city of Marion. The wrong-way vehicle was traveling in the outside lane, and the Sheriff's department was traveling in the center lane. As they approached the Hernando DeSoto Bridge, the driver struck the left side of the Sheriff's vehicle to avoid capture, this caused the wrong-way driver to lose control of his vehicle and hit the concrete barrier. The vehicle came to rest facing eastbound in the westbound lanes.

The interchange at Exit 280 was reviewed. Pavement markings and signs were in place and in conformance with MUTCD requirements. However, the 36"x36" Do Not Enter, 48"x48" Stop, and 54"x18" One Way signs were replaced to be consistent with current ARDOT requirements on February 14, 2022.

The interchange at Exit 281 was reviewed. Signs were in place and in conformance with MUTCD requirements. However, the 30"x30" Do Not Enter, 36"x36" Stop, and 36"x12" One Way signs needed to be installed, the pavement markings (stop bar) had faded, and the pavement marking arrow needed to be moved up 400 ft. to be consistent with current ARDOT requirements. These modifications were implemented on February 14, 2022.

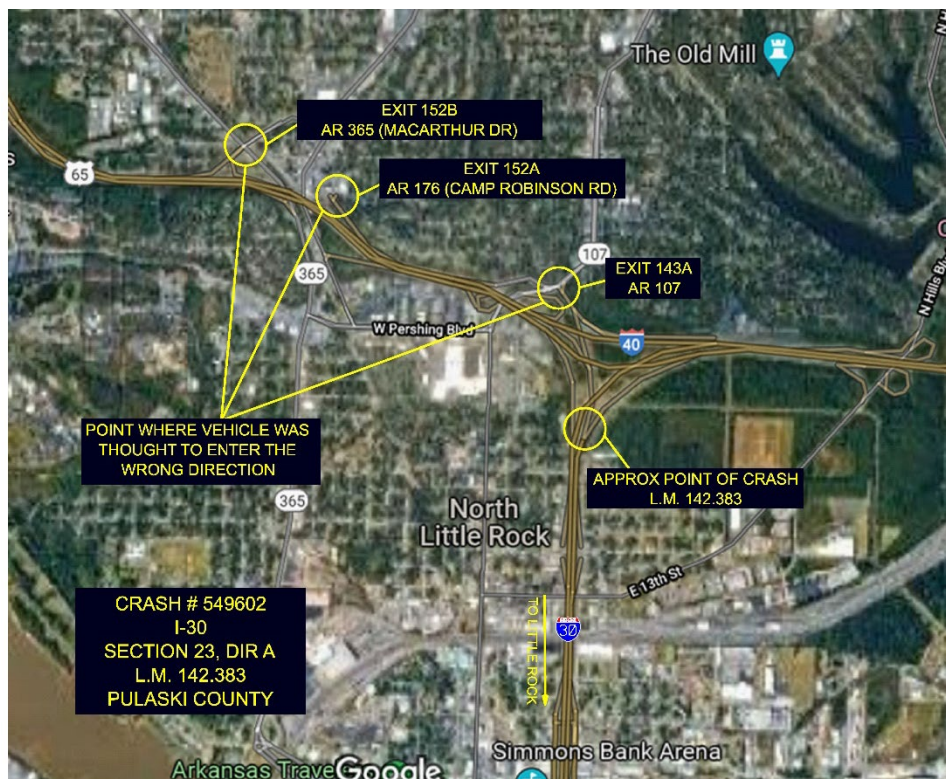
Crash # 2020549602 I-30, Section 23, Direction A, Log Mile 142.383

The driver accessed I-30 possibly at Exit 143A (AR 107), Exit 152A (AR 176, Camp Robinson Rd.), or Exit 152B (AR 365, MacArthur Dr.) and traveled westbound on the Interstate 30 eastbound traffic lane. The wrong-way driver came across the gore and was involved in a head on collision. The wrong-way driver was suspected of being under the influence of alcohol.

The interchange at Exit 152A was reviewed. Pavement markings and signs were in place and in conformance with MUTCD and ARDOT requirements.

The interchange at Exit 152B was reviewed. Pavement markings and signs were in place and in conformance with MUTCD and ARDOT requirements.

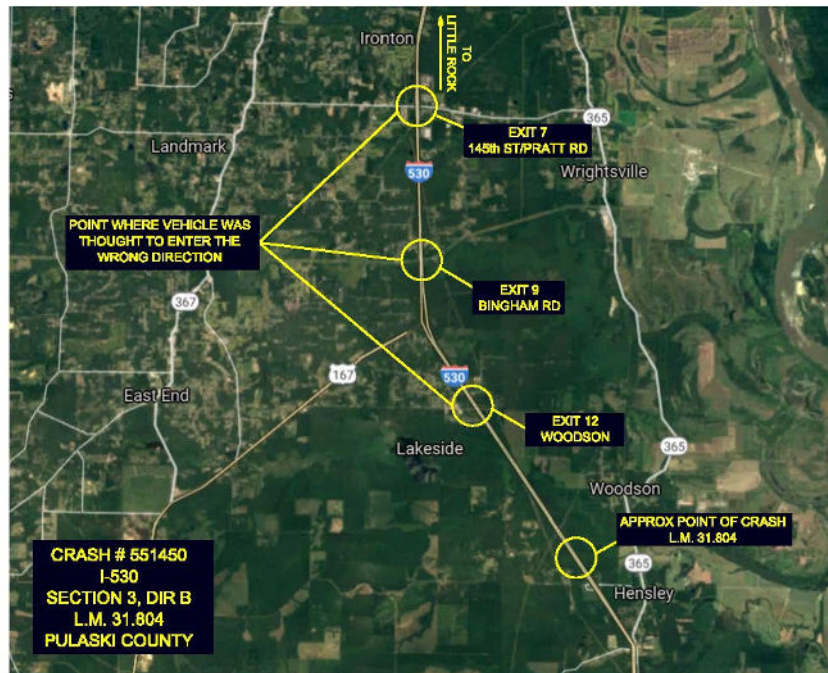
Crash # 2020551450 I-530, Section 3, Direction B, Log Mile 31.804

The driver accessed I-530 possibly at Exit 7 (145th St./Pratt Rd.), Exit 9 (Bingham Rd.), or Exit 12 (Woodson) and traveled southbound in the northbound traffic lane on I-530. The intoxicated driver was traveling on the wrong side of the interstate and collided head on with another vehicle.

The interchange at Exit 7 was reviewed. Pavement markings and signs were in place and in conformance with MUTCD. However, the 36"x36" Stop, 30"x30" Do Not Enter, and 36"x12" One Way assembly were missing. They were installed to be consistent with current ARDOT requirements on December 16, 2021.

The interchange at Exit 9 was reviewed. Pavement markings and signs were in place and in conformance with MUTCD. However, the 36"x12" One Way signs were missing but were installed to be consistent with current ARDOT requirements on December 16, 2021.

The interchange at Exit 12 was reviewed. Pavement markings and signs were in place and in conformance with MUTCD and ARDOT standards. However, one of the red vertical reflective strips was missing. It was installed on the "Wrong Way" signpost to be consistent with current ARDOT requirements on December 16, 2021.

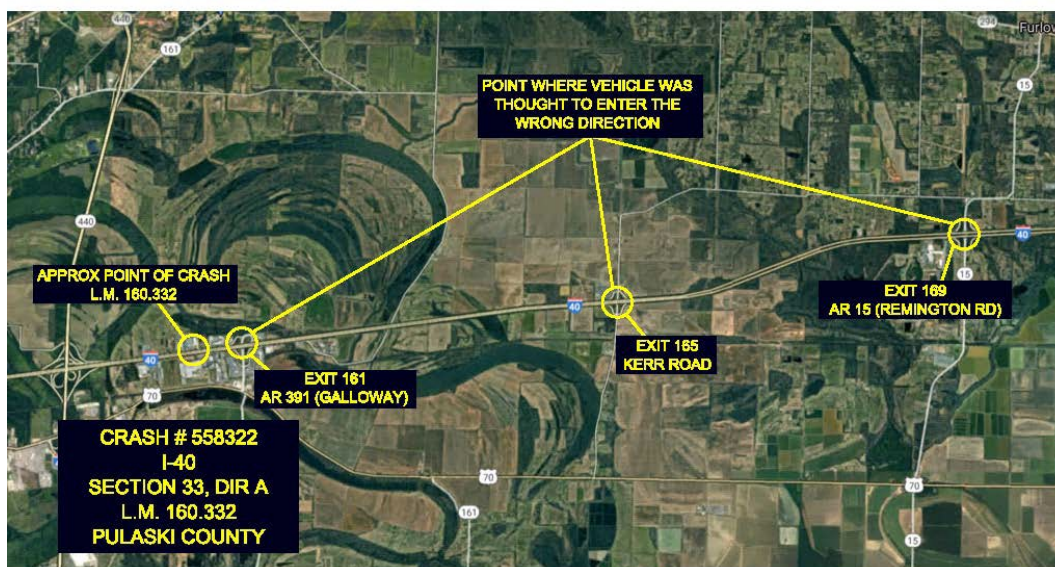
Crash # 2020558322 I-40, Section 33, Direction A, Log Mile 160.332

The driver accessed I-40 possibly at Exit 161 (AR 391, Galloway), Exit 165 (Kerr Road) or Exit 169 (AR 15, Remington Rd.) and traveled westbound in the eastbound traffic lane on I-40. The wrong-way driver was traveling west on the south shoulder and then turned north across both lanes. The eastbound vehicle was unable to stop, and the front end collided with the front driver's side. After impact, the vehicle rotated east, left the roadway, and came to rest facing south on the south shoulder. The eastbound vehicle left the roadway to the south and collided with a large drainage ditch and came to rest with the front end lodged in a dirt embankment.

The interchange at Exit 165 was reviewed. Signs were in place and in conformance with MUTCD requirements. However, the 30"x30" Do Not Enter sign was missing and the pavement marking arrow needed to be installed to be consistent with current ARDOT requirements. These modifications were implemented on January 10, 2022.

The interchange at Exit 169 was reviewed. Signs were in place and in conformance with MUTCD. However, the 36"x12" One Way signs were missing or damaged and the pavement marking arrow needed to be moved up 300 feet to be consistent with current ARDOT requirements. These modifications were implemented on January 10, 2022.

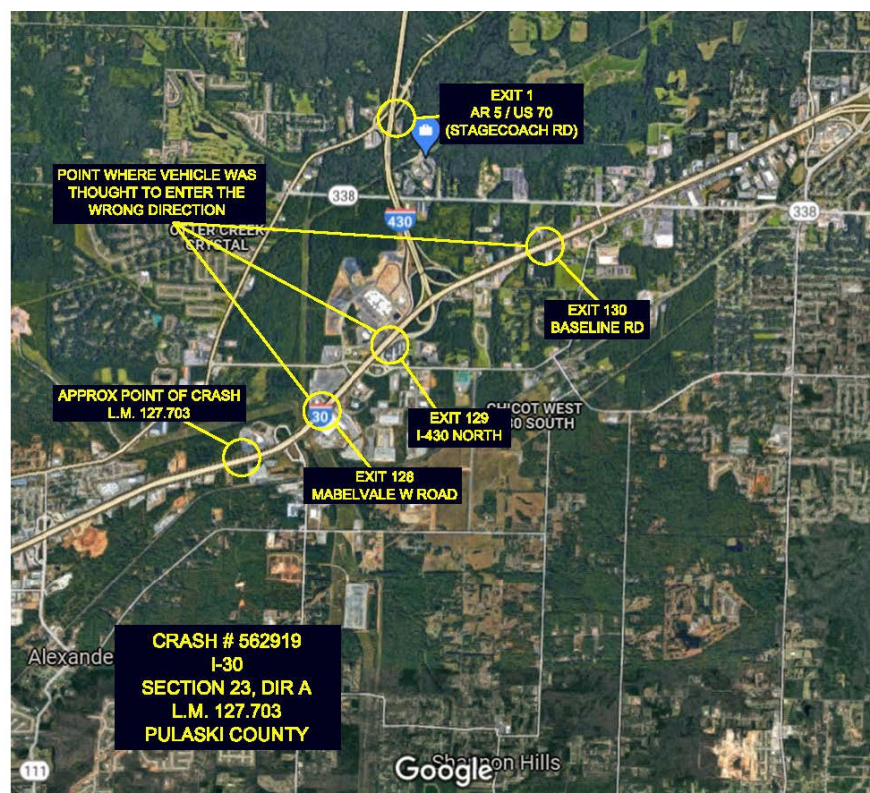
Crash # 2020562919 I-30, Section 23, Direction A, Log Mile 127.703

The driver accessed I-30 possibly at Exit 128 (Mabelvale W Rd.), Exit 129 (I-430 North), or Exit 130 (AR 338, Baseline Rd.) and traveled westbound in the eastbound traffic lane on I-30. The wrong-way driver was involved in a head on collision at mile marker 127.703. Another eastbound vehicle attempted to avoid the collision but was unable to do so. This vehicle left the roadway onto the left shoulder after striking an unknown object involved in the collision and struck the concrete barrier on the left shoulder, spun counterclockwise, and came to final rest facing west on the left shoulder. The wrong-way driver was suspected of being under the influence of alcohol or drugs at the time of the crash.

The interchange at Exit 129 was reviewed. Pavement markings and signs were in place and in conformance with MUTCD and ARDOT requirements.

The interchange at Exit 130 was reviewed. Pavement markings and signs were in place and in conformance with MUTCD requirements. However, an additional 36"x36" Do Not Enter sign needed to be installed at the exit ramp, and other 30"x30" Do Not Enter signs needed to be upsized to 36"x36" with their posts delineated with the red vertical reflective strips to be consistent with current ARDOT requirements. These modifications were implemented on December 15, 2021.

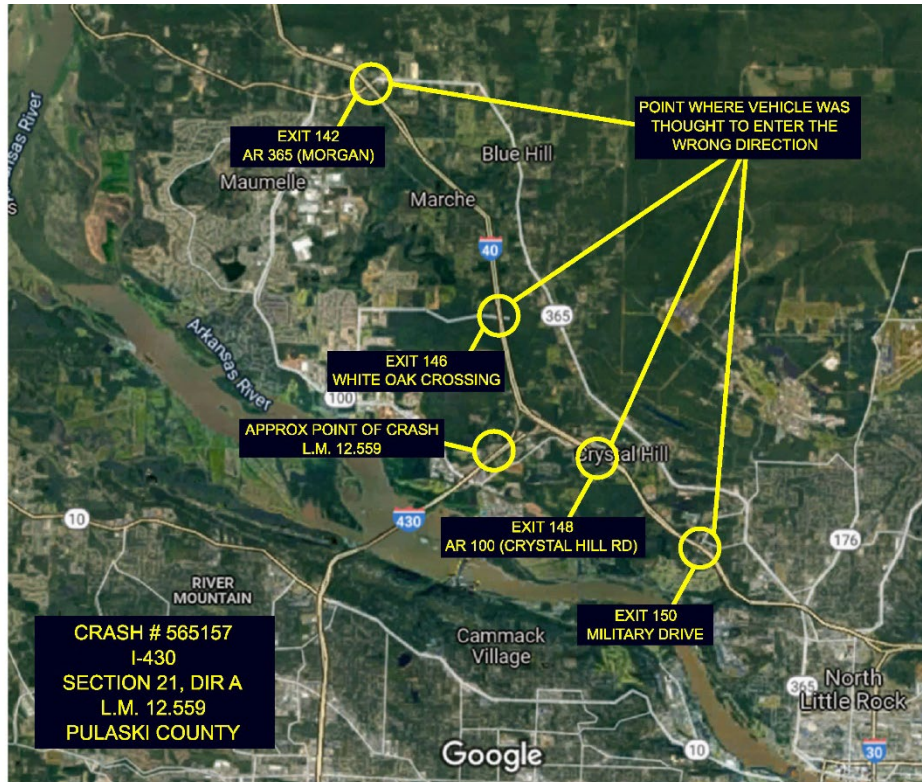
Crash # 2020565157 I-430, Section 21, Direction A, Log Mile 12.559

The driver accessed I-430 possibly at Exit 142 (AR 365, Morgan), Exit 146 (White Oak Crossing), Exit 148 (AR 100, Crystal Hill Rd.), or Exit 150 (Military Drive) and traveled southbound in the northbound traffic lane on I-430. The wrong-way driver crossed into the occupied number one traffic lane. The northbound vehicle veered to the right just prior to impact avoiding a head on collision. The wrong-way vehicle struck the left side of the northbound vehicle with the left front of his vehicle. The northbound vehicle rotated slightly clockwise and continued traveling north coming to rest facing east on the shoulder. The wrong-way vehicle continued traveling southeast with the left front wheel assembly torn from the vehicle and came to rest facing southeast. The wrong-way driver was under the influence of alcohol.

The interchange at Exit 148 was reviewed. Pavement markings and signs were in place and in conformance with MUTCD and ARDOT requirements.

The interchange at Exit 150 was reviewed. Pavement markings and signs were in place and in conformance with MUTCD and ARDOT requirements.
